# Data Recovery from Aircraft Black Box

Michał Gmurek

Techno Security &  
Digital Forensics  
Conference

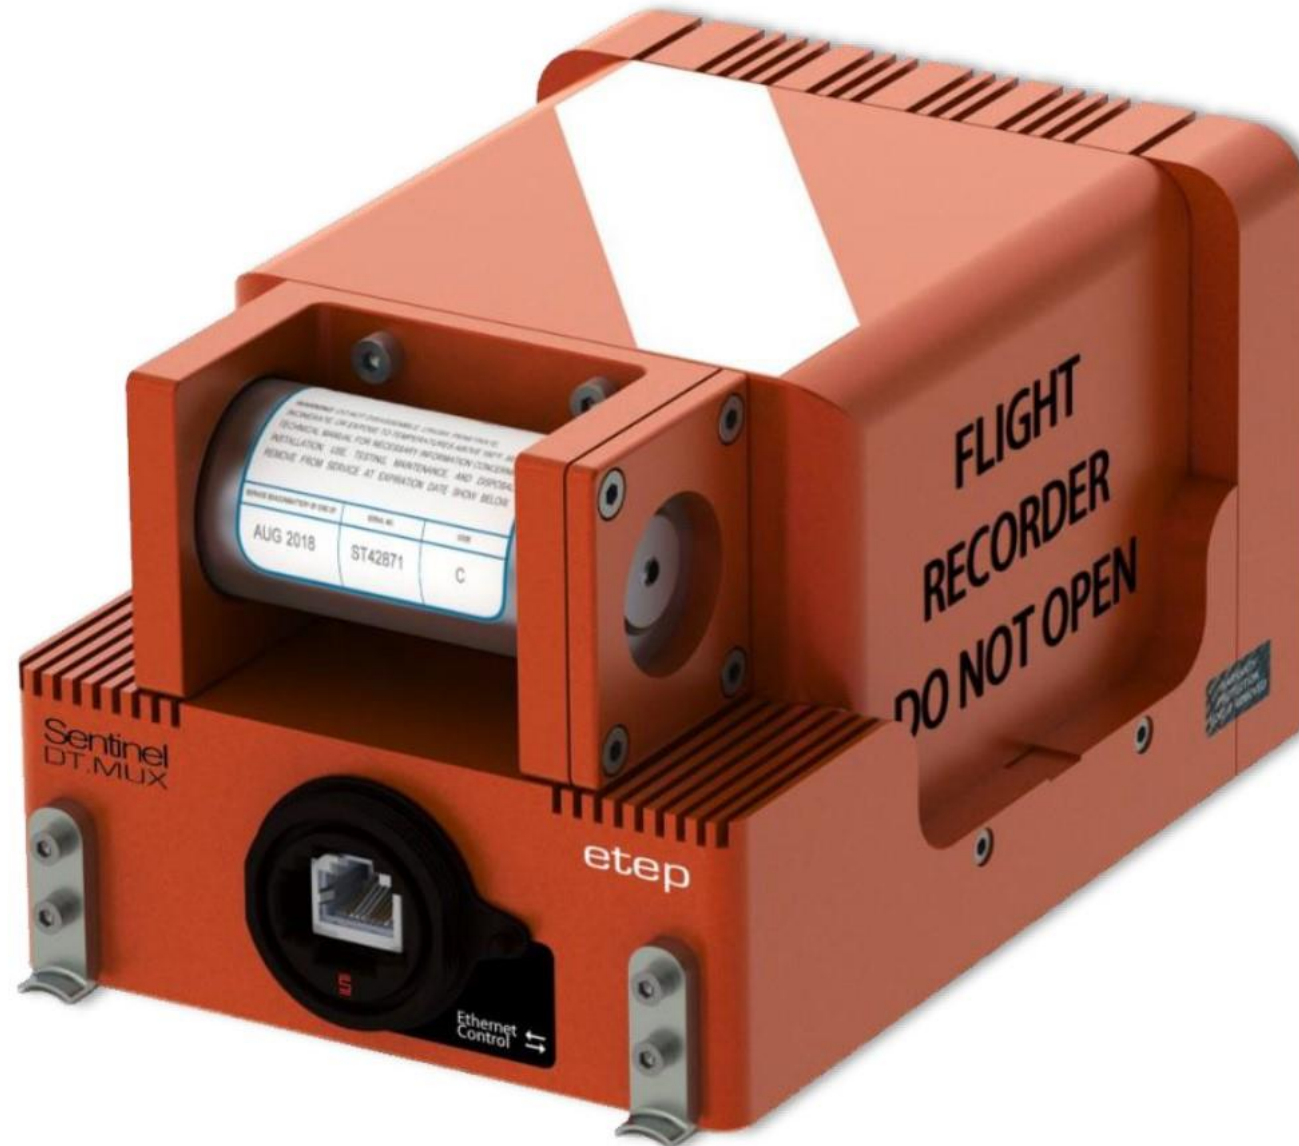
**Cockpit voice recorder**  
preserves pilot voices  
and cockpit sounds.

**Flight data recorder**  
captures such  
information as altitude,  
airspeed, heading and  
engine thrust.

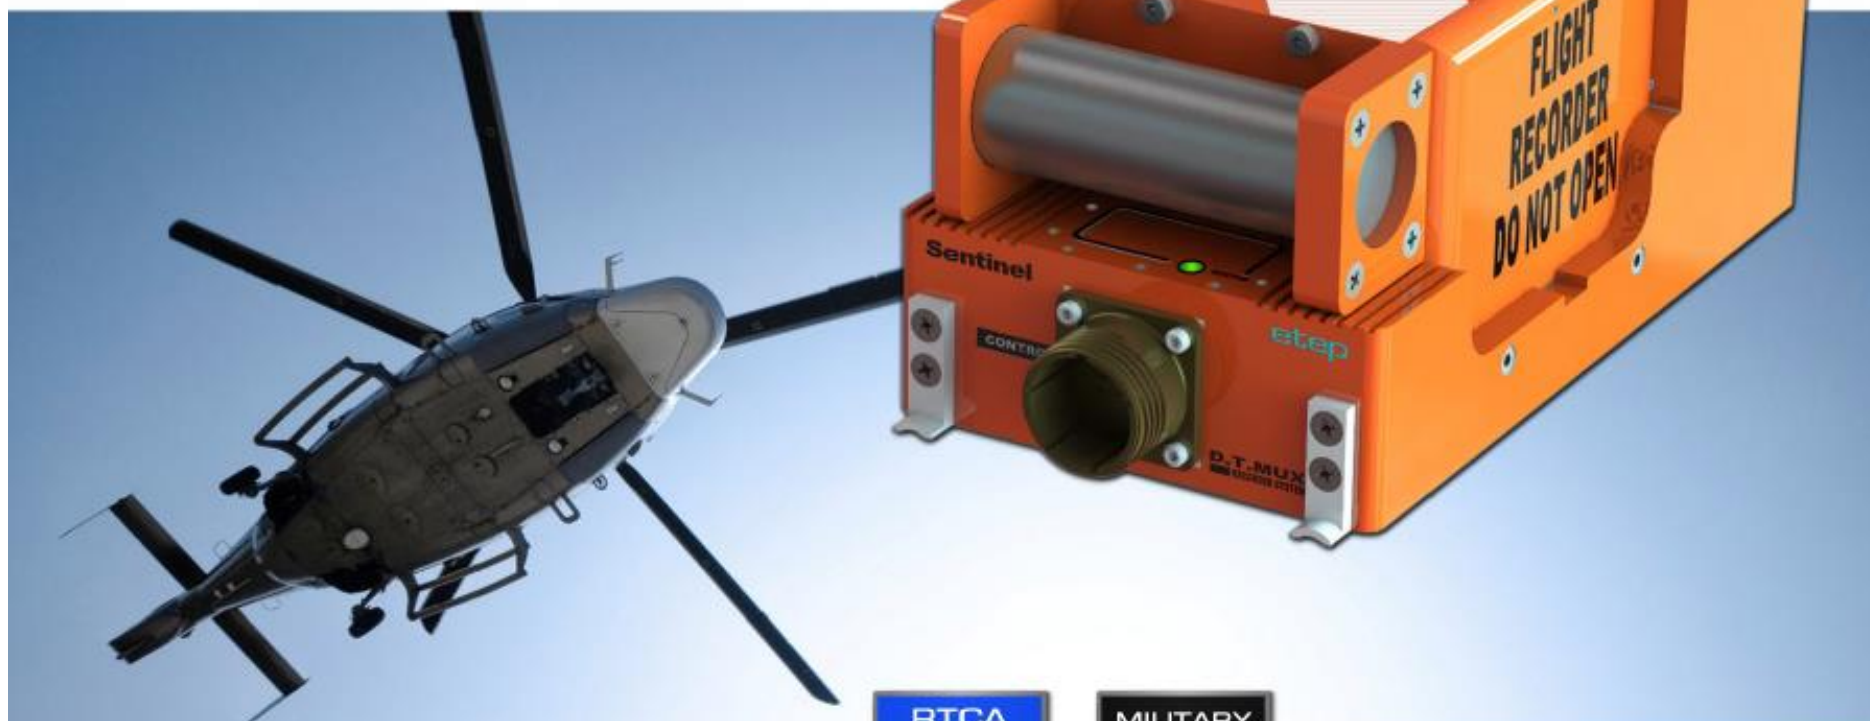
# D.T.MUX Sentinel™

Crash Protected System  
from 32 to 128GB

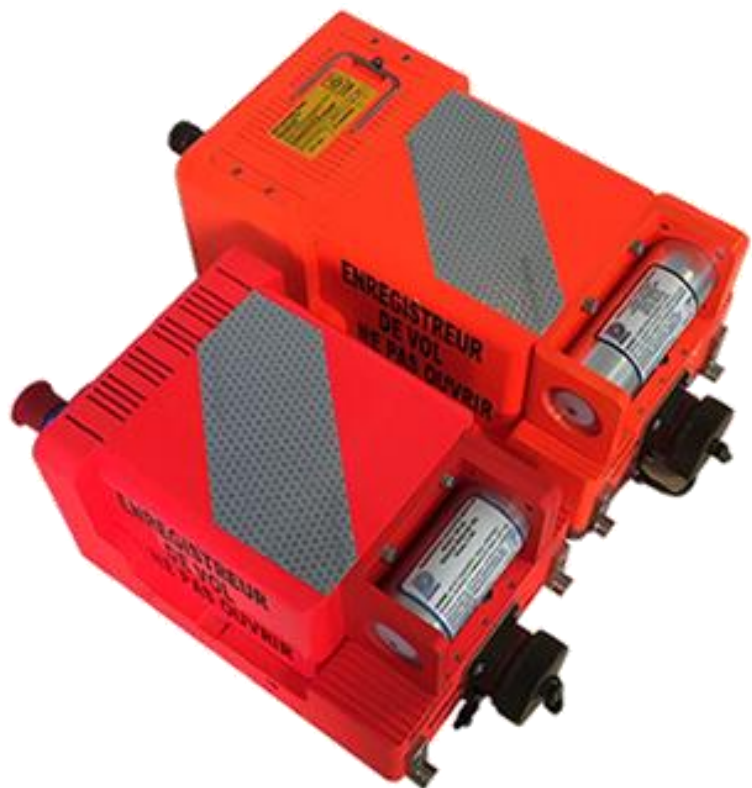
Specification	Remark
<b>Size</b>	189.5 (231.8 iRIPS / 219.5 iEE) x 126.2 x 101 mm	D x W x H ± 1mm
<b>Weight</b>	≈ 3.30kg / 3.75kg ≈ 4.85kg	ED155/ ED112 iRIPS
<b>Connectors</b>	MIL-DTL-38999	Serie III
<b>Mounting</b>	ARINC 404	Customizable

<b>Input Voltage</b>	28Vdc (16 to 36Vdc)
<b>Power consumption</b>	≈ 12 to 32 watts (28Vdc)
<b>Power Interruption</b>	≈ 200 to 800ms
<b>Standard</b>	MIL-STD-704F / DO-160

Specification	Remark
<b>Temperature</b>	-40°C to 65°C -55°C to 90°C	Operating Storage
<b>Cooling</b>	Passive	Convection
<b>Humidity</b>	95%	Non-Cond
<b>Vibration</b>	5Hz to 2KHz	6.29 g RMS
<b>Shocks</b>	20g 11ms	Operating
<b>Acceleration</b>	20g linear 3 axis	Operating
<b>Altitude</b>	+ 60,000 ft	Operating
<b>Decompression</b>	420Kpa/minute	Operating
<b>MTBF</b>	> 90,000 hours	Computed
<b>EMI</b>	DO-160	Rev G

Specification
<b>Gigabit</b>	Configuration/Control
<b>Ethernet</b>	Data download and Streaming
<b>Time synch</b>	GPS Antenna input / Irig B / PTP v2
<b>Voice</b>	4x Audio channels
<b>Recording</b>	IRIG 106 Chapter 10 / DTMUX format
<b>Sensors</b>	Internal 3 Axis Gyro/ G force/ Pressure
<b>COM port</b>	RS-232 Configuration/Maintenance
<b>Status</b>	Status Led / Status output

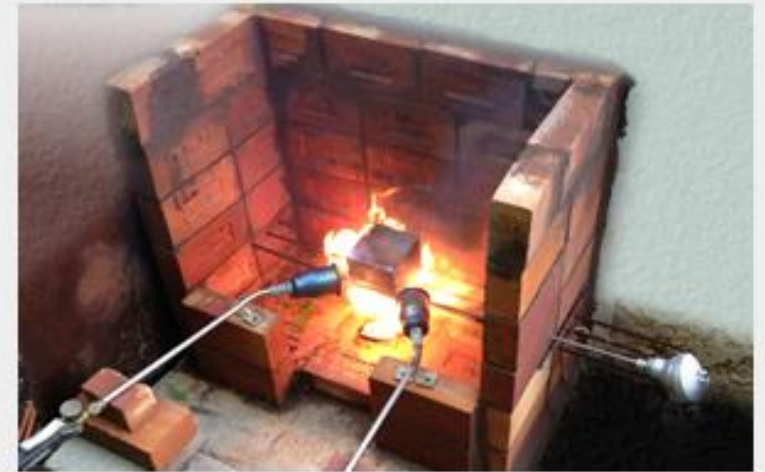
Sentinel Under High temperature fire test

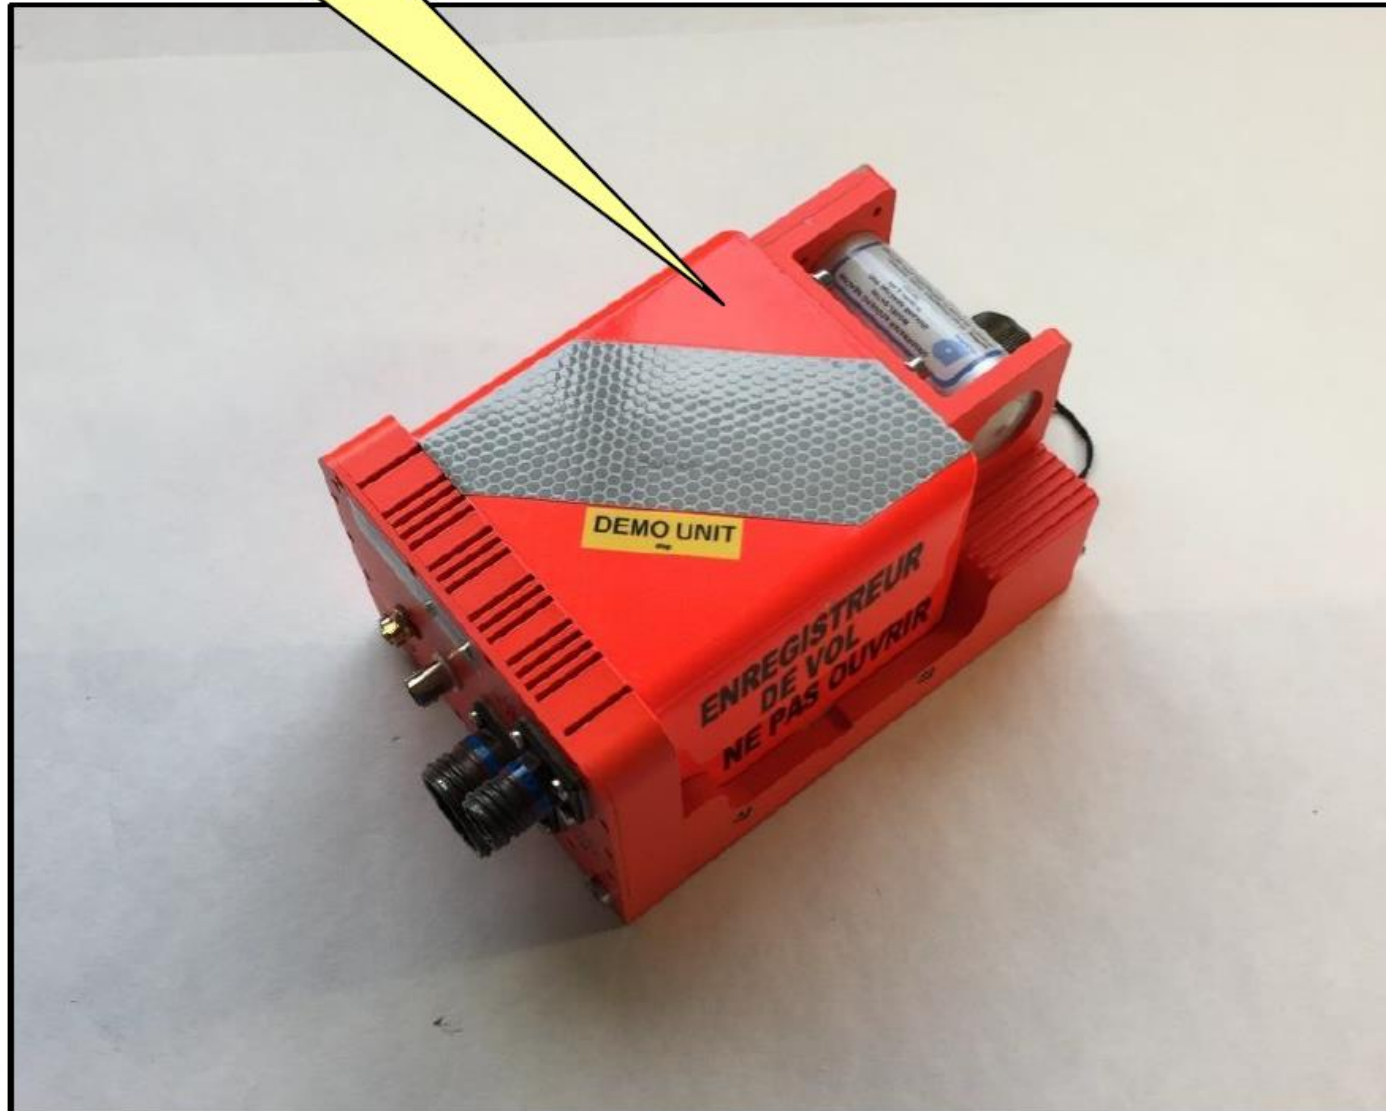
Crash Protected  
Memory Block

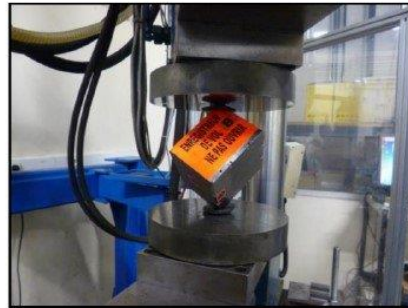
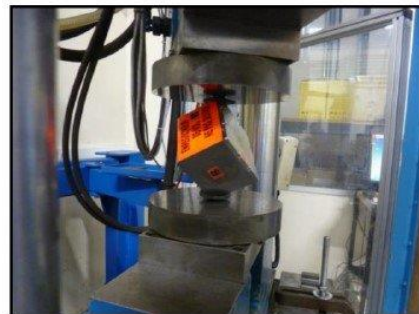
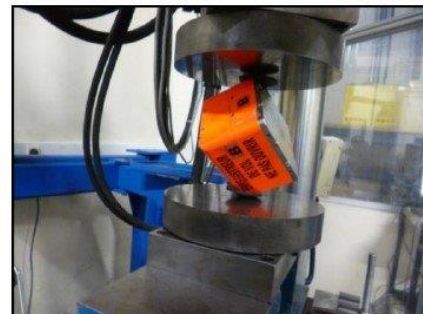
# Hydraulic press test

Diagonal 1

Diagonal 2

Diagonal 3

Diagonal 4

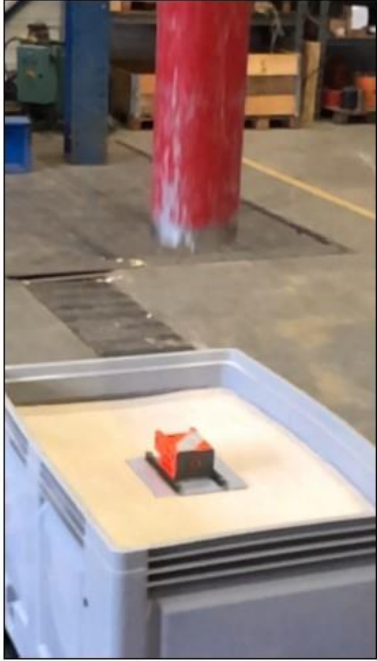
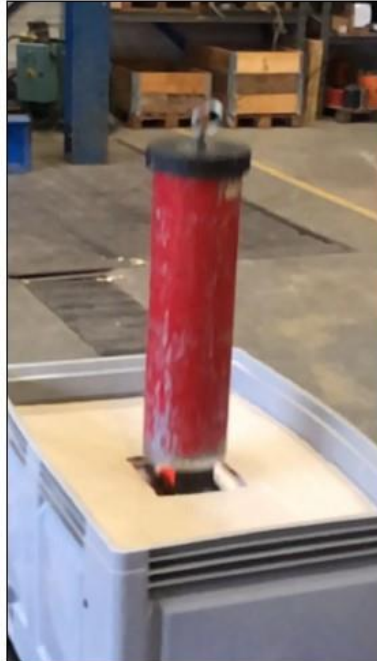
Sentinel CSMU

Sandbox

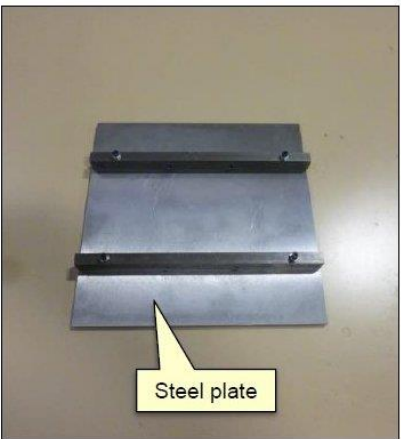
Penetration pin

Steel plate

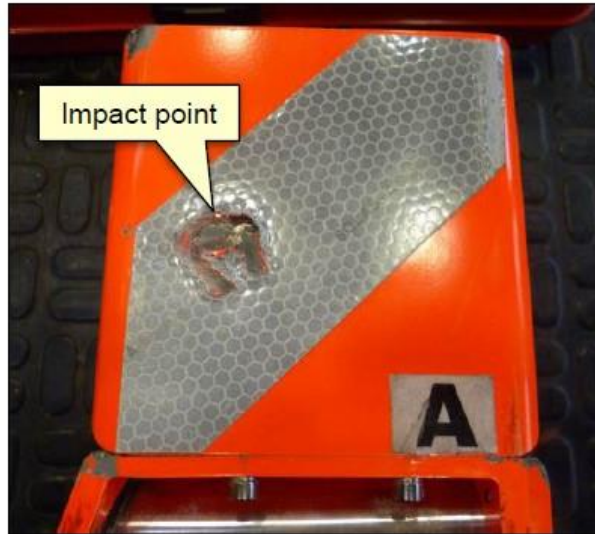
# Mechanical crash test results

CSMU "A", "B" and "C" has successfully pass test sequence, no penetration or deformation of structure has been noted for each one.

Data contained inside robust memory are not analyzed before end of test sequence.

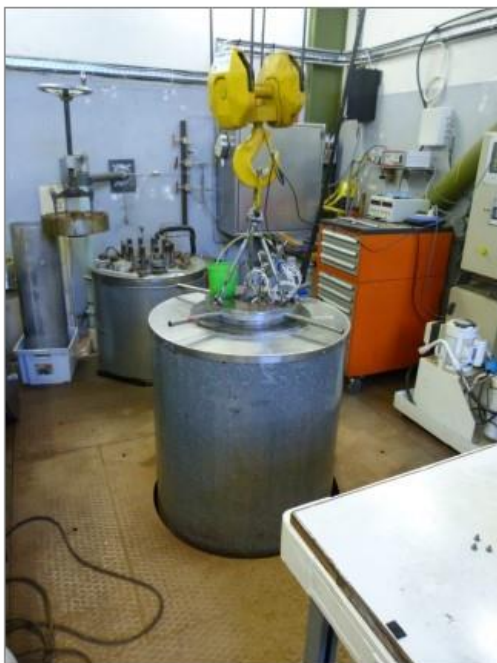
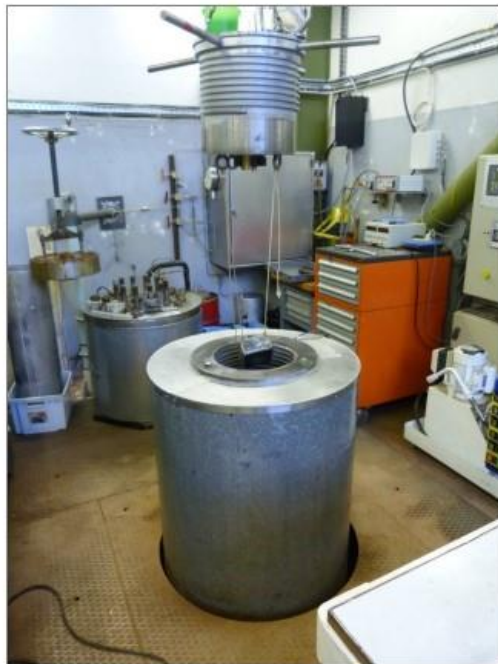
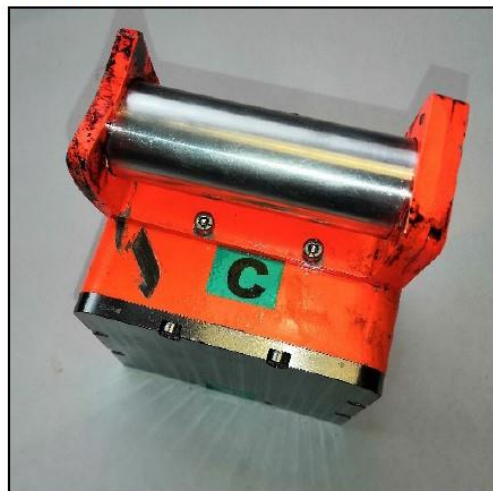
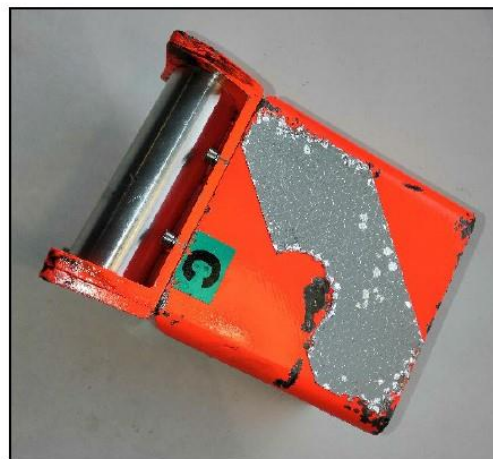
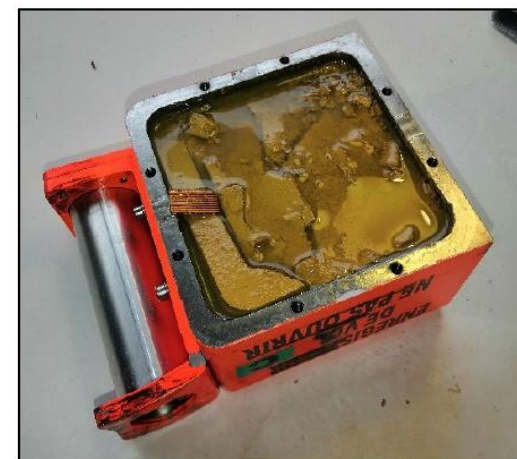
# High pressure test

The Sentinel CPM is placed in hyperbaric chamber during 24 hours at 625 Bar, in saltwater to simulate a depth of 6000m. The materials used to protect the recording medium have been shown to be unaffected by sea water (Titanium ...)

This test must determinate if the crash protected memory Sentinel can resist to an equivalent depth of 6 000 m (20 000 feet).

We no detected any change of the Sentinel CPM structure after 24 hours at 625 Bar.

After this test in laboratory we don't note any deformation of the structure, and the structure is remains in **full integrity**.

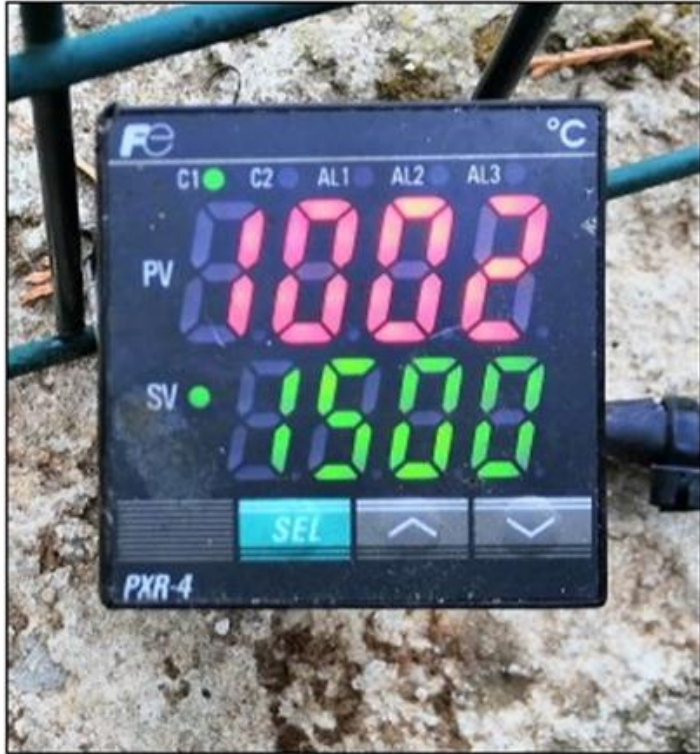
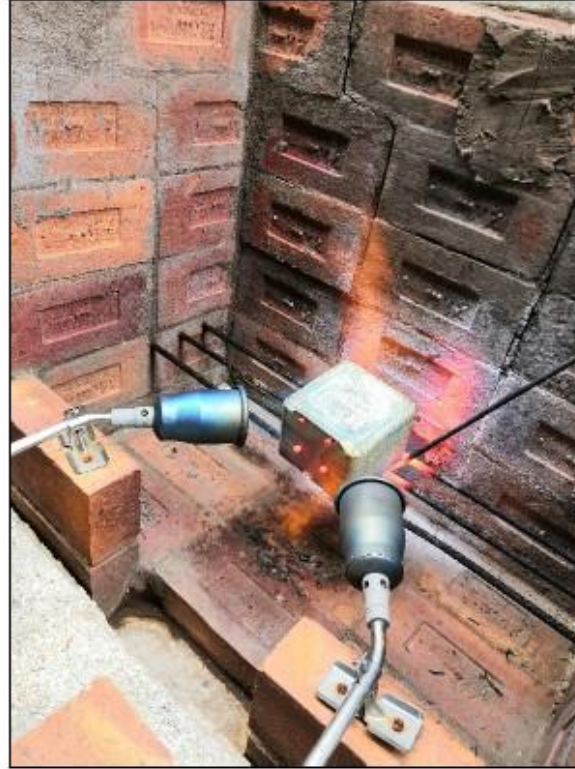
# High temperature test

Test has been conducted on Crash Protected memory unit destined to equip Sentinel System. The fire test is started by turning on the main gas valve. Flame temperature, as indicated by the external thermocouples, is continuously monitored. Figure 2 picture show Crash Protected Memory module under high temperature test.

At the end of the test period, the burners have been shut off and the robust memory module has been cool naturally in ambient conditions. The crash Protect memory unit has been removed from the vicinity of the support arrangement.

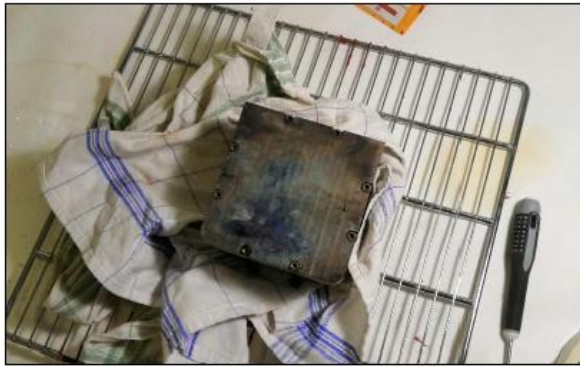
# High temperature test results

The unit is progressively put back to room temperature (natural cooling) the time is approximately 3 hours before being able to go for opening process.

we don't notice any deformation of the structure and the structure is in **full integrity**. Bright orange paint has disappeared.

Reached temperature inside enclosure up to 132°C

After this test the Sentinel crash protected memory is open to verify if the PCB did not damaged and if the data is still readable. After remove of all insulation protection (Ceramic, white powder material and red silicon protection), we examine the memory PCB.

After a visual inspection, we no detect any damages on solid state drive circuit.

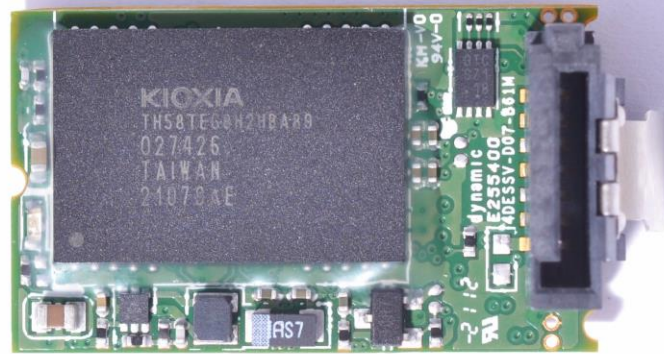
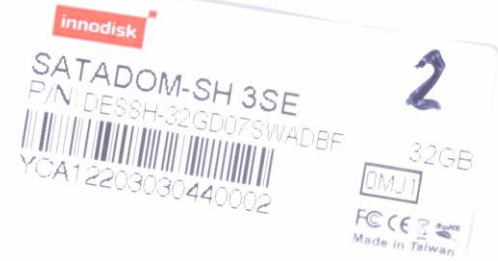
On the other side of PCB we can see the microcontroller

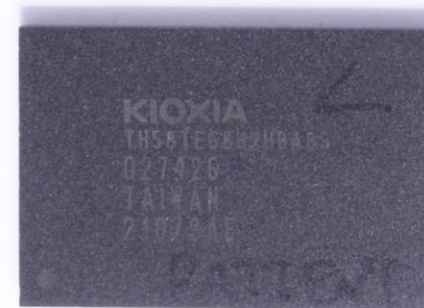
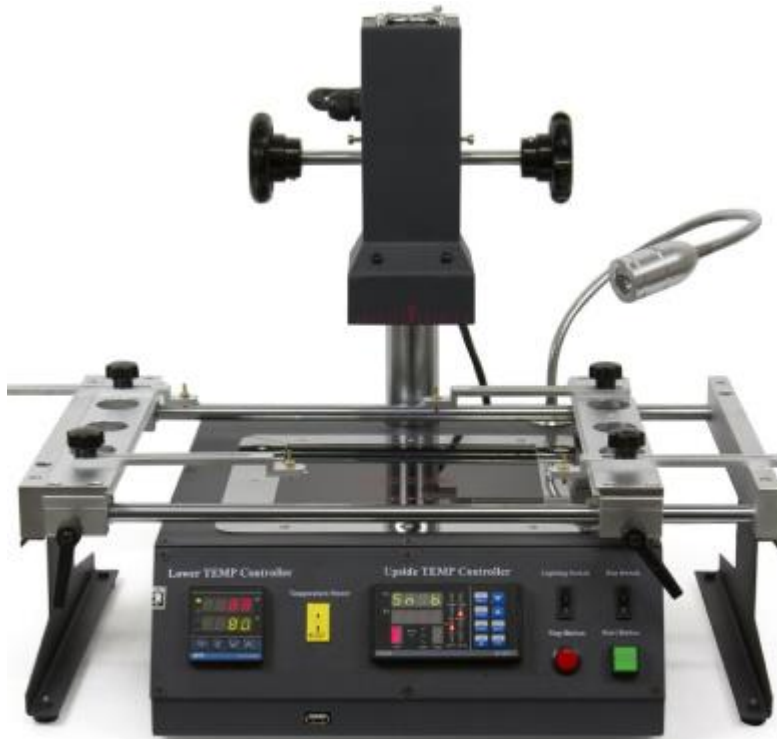
# Unsoldered NAND memory – top view

The memory chip was removed from the PCB for further reading using InfraRed rework station and thermal profile of  $T_{max} = 240C$  ( $T_{delta} \sim 3C/s$ )

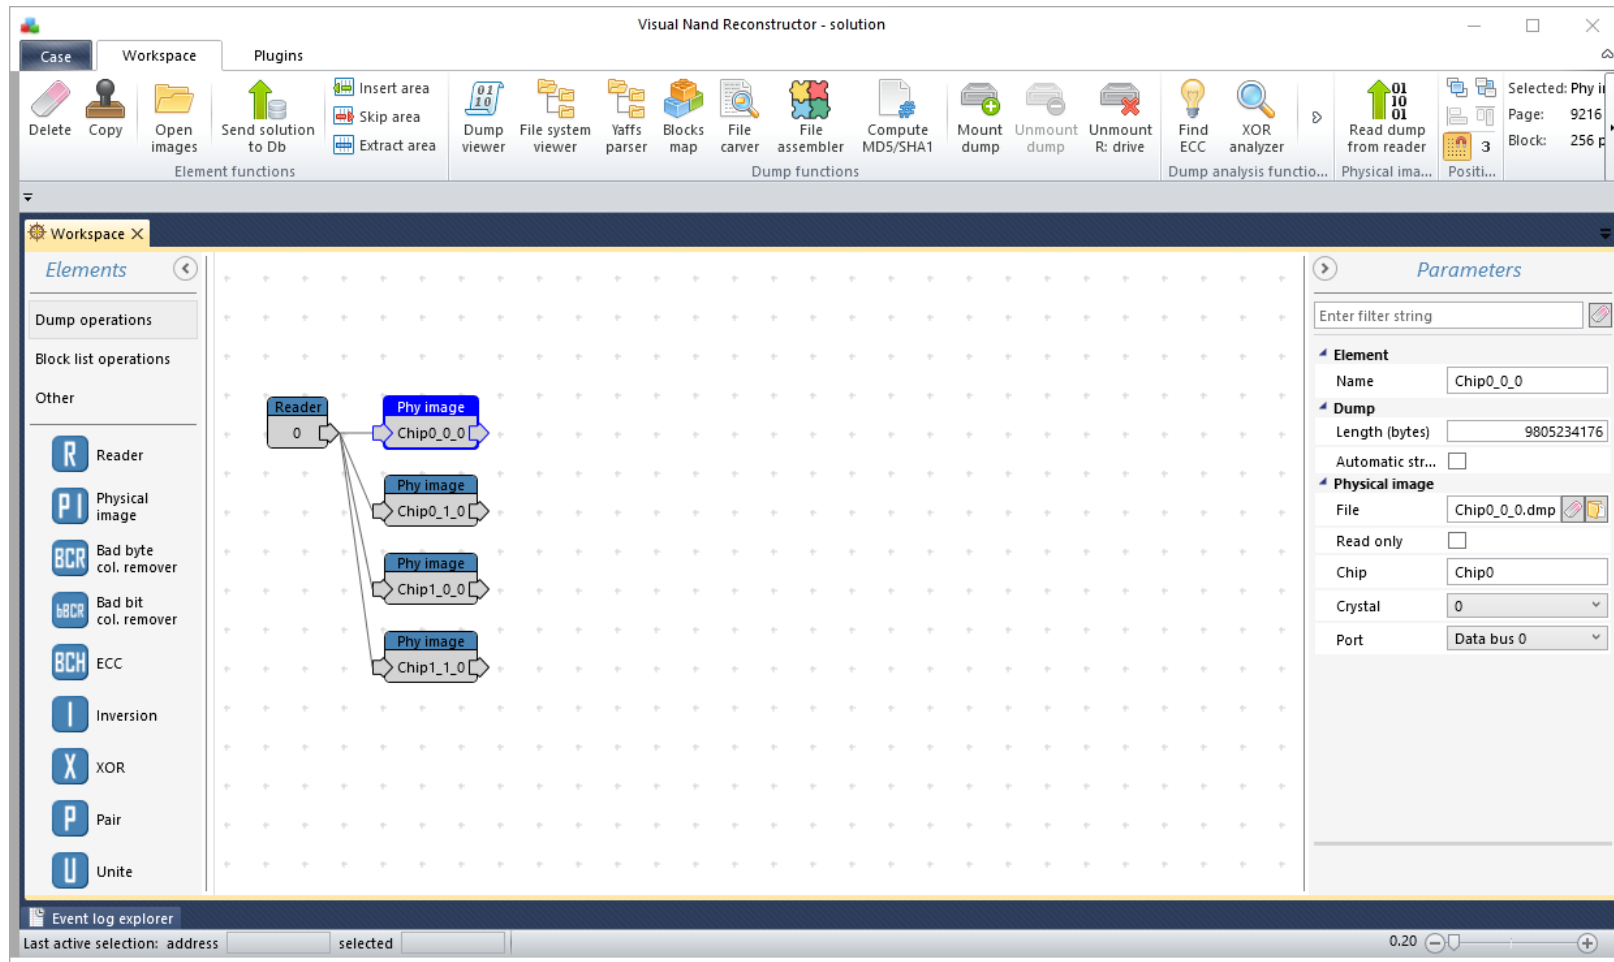
# Physical image extraction from NAND

We used Visual NAND Reconstructor for memory chip reading and physical image processing. In total 4 dumps/physical images were extracted out of the NAND.

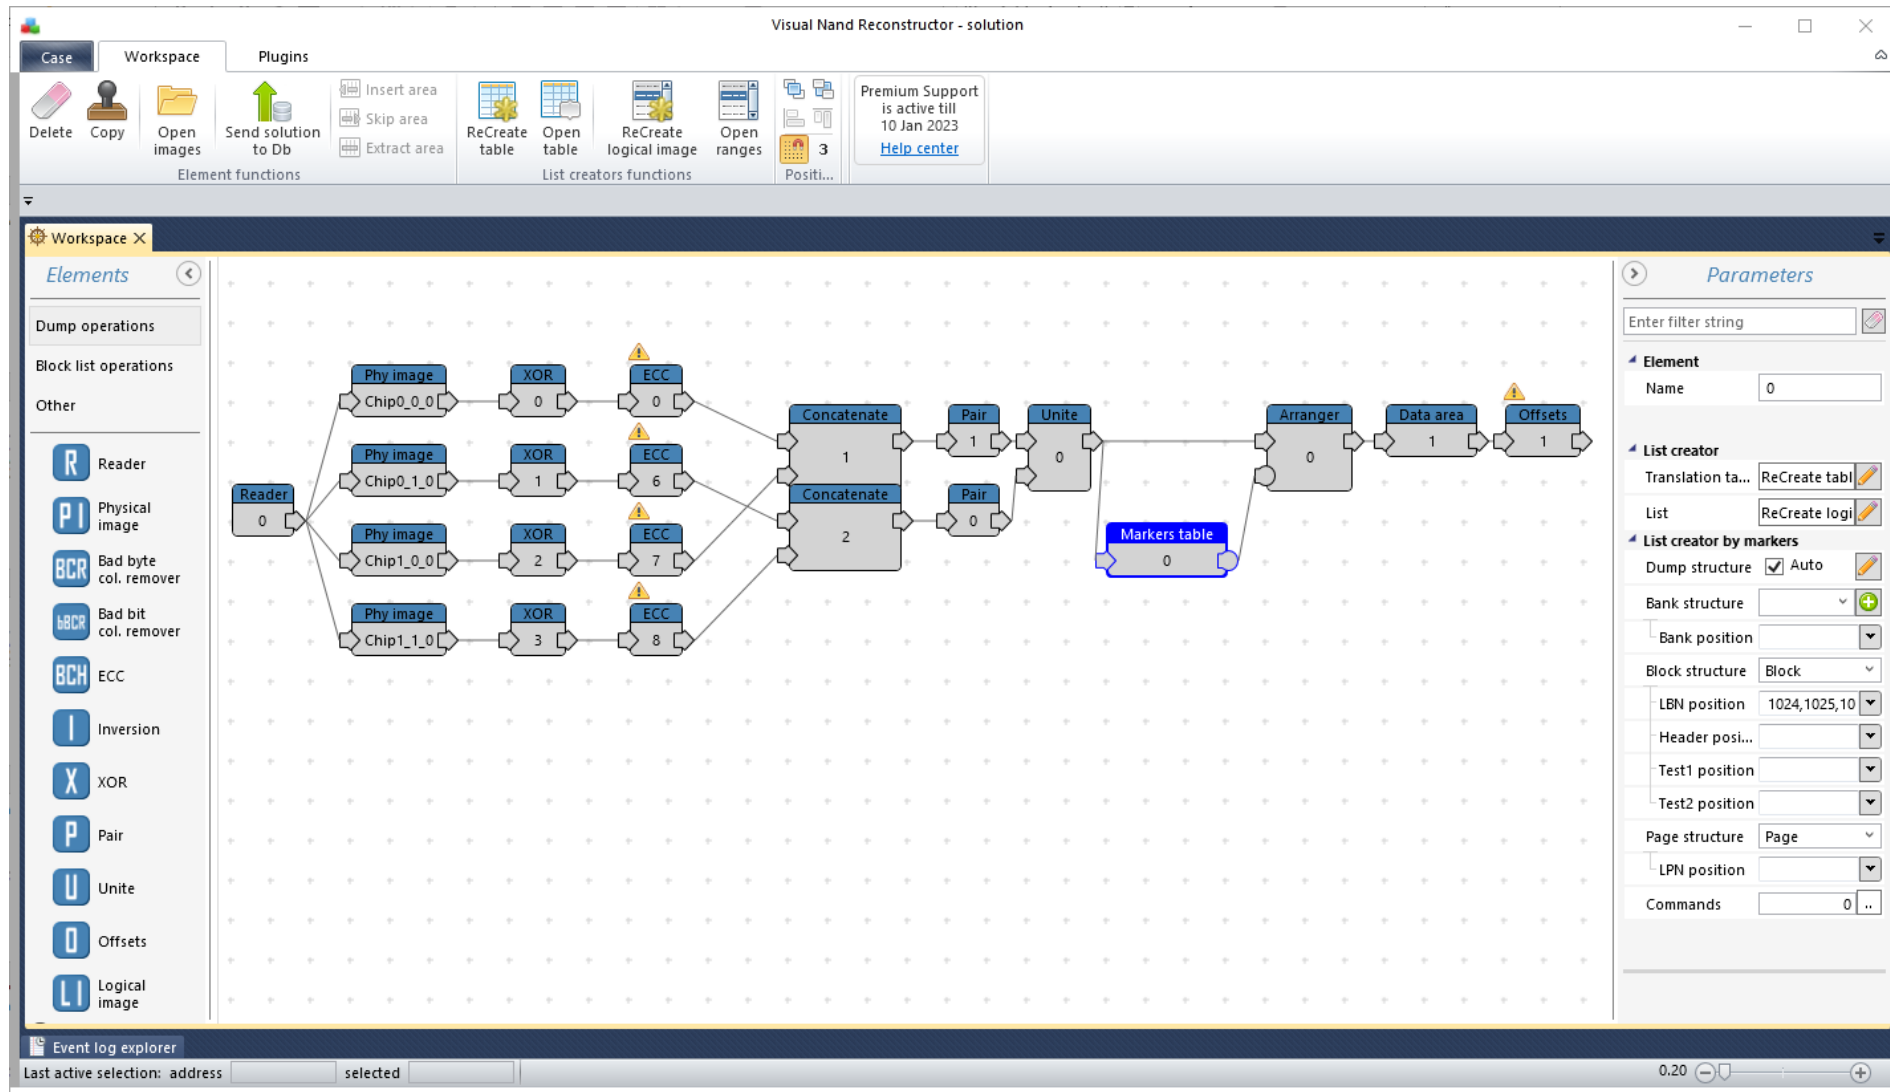
# Reconstruction of controller's workflow

Physical image has been converted to logical image through controller's emulation process
