Odzyskiwanie danych z czarnej skrzynki

Łukasz Pietrzykowski

D.T.MUX Sentinel™

Crash Protected System
from 32 to 128GB

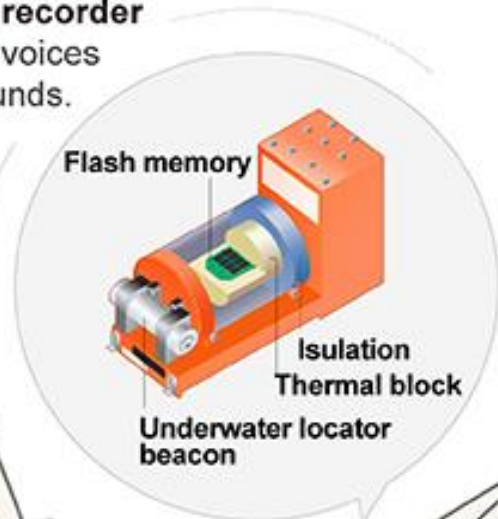
Rejestrator dźwięków kokpitu

Cockpit voice recorder
preserves pilot voices
and cockpit sounds.

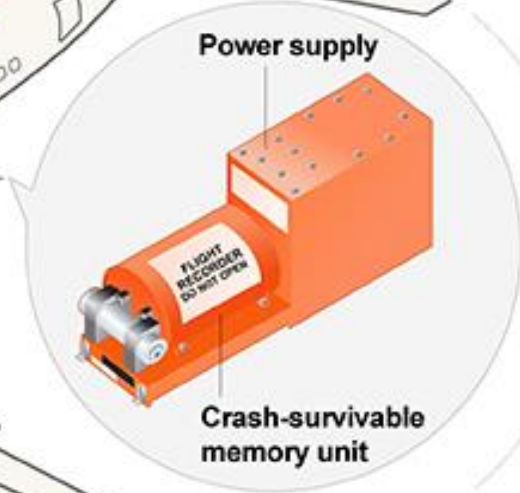
Rejestrator parametrów lotu

Flight data recorder
captures such
information as altitude,
airspeed, heading and
engine thrust.

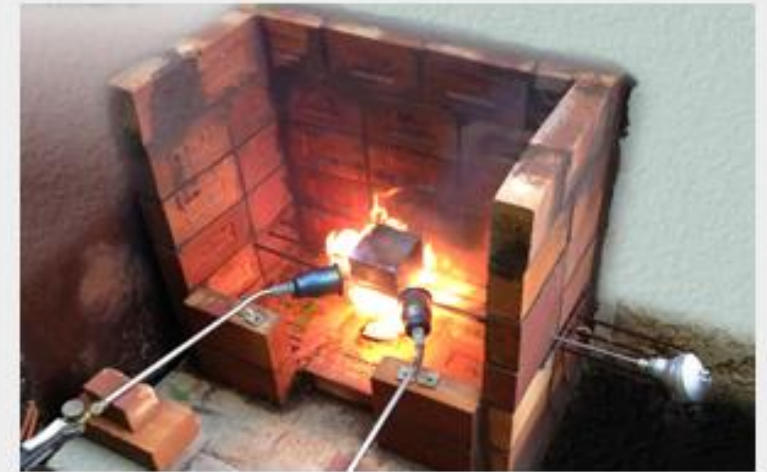
Sentinel Under High temperature fire test

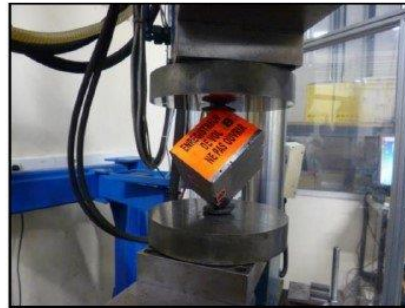
Diagonal 1

Testy przeciążeniowe – nacisk prasy hydraulicznej pod różnymi kątami

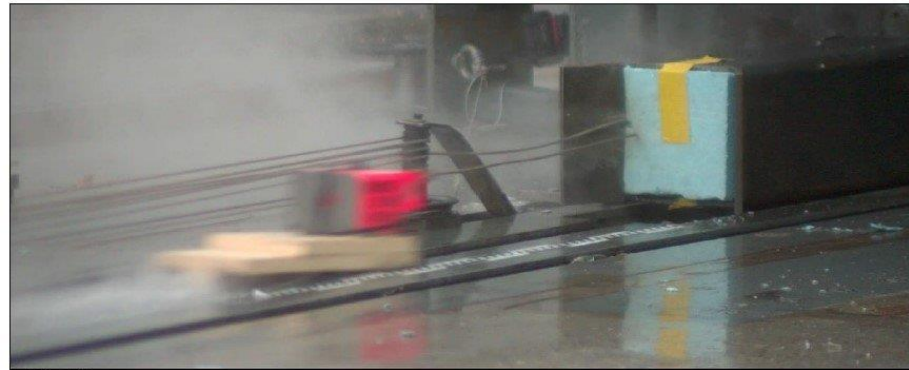
pSi-19-1386, ETEP- Impact Shock Test 02 B X+

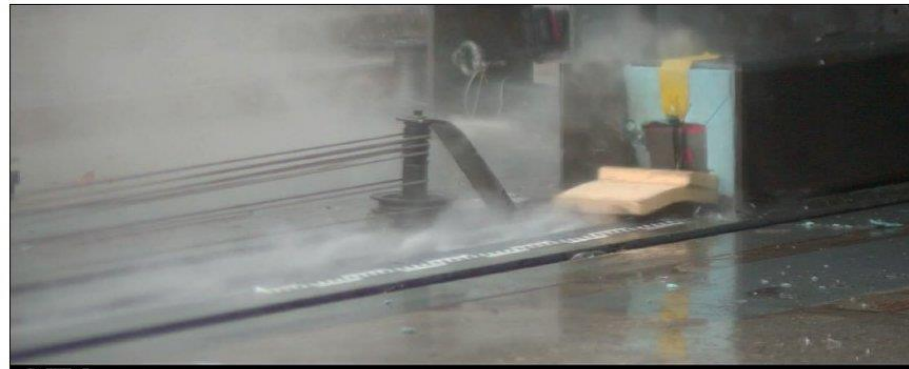
pSi-19-1386, ETEP- Impact Shock Test 02 B X+

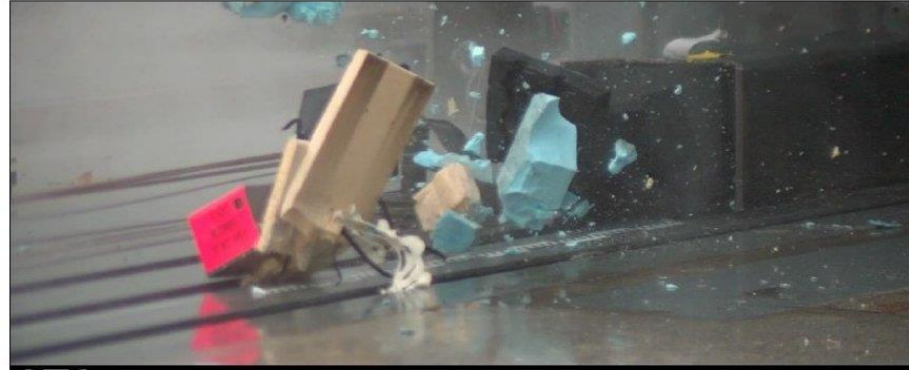
pSi-19-1386, ETEP- Impact Shock Test 02 B X+

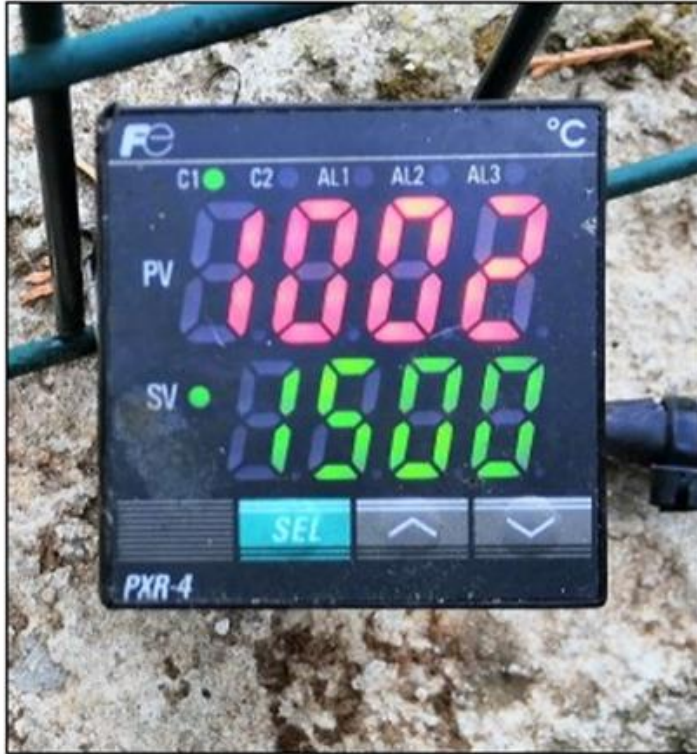
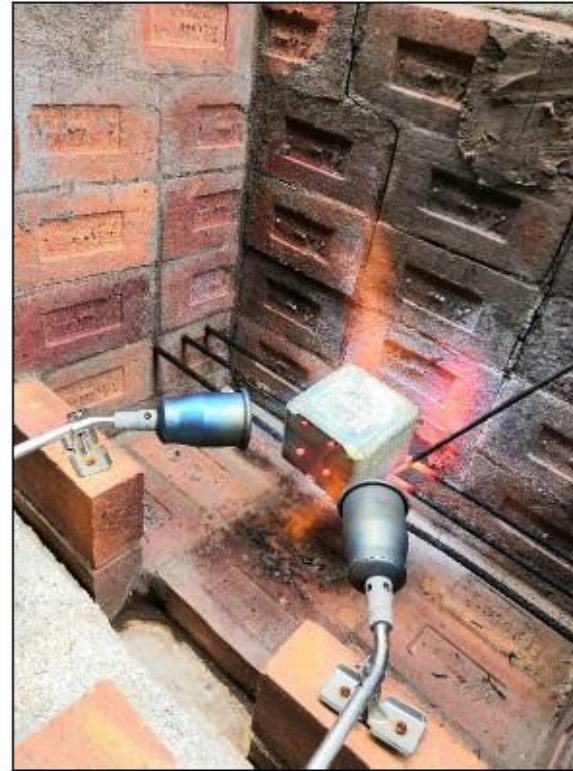
Testy temperaturowe

Test has been conducted on Crash Protected memory unit destined to equip Sentinel System. The fire test is started by turning on the main gas valve. Flame temperature, as indicated by the external thermocouples, is continuously monitored. Figure 2 picture show Crash Protected Memory module under high temperature test.

At the end of the test period, the burners have been shut off and the robust memory module has been cool naturally in ambient conditions. The crash Protect memory unit has been removed from the vicinity of the support arrangement.

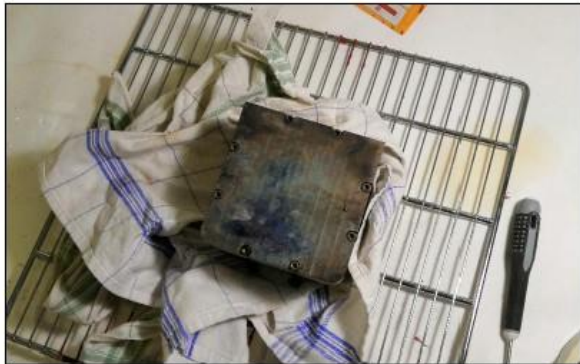
Testy temperaturowe - wyniki

The unit is progressively put back to room temperature (natural cooling) the time is approximately 3 hours before being able to go for opening process.

we don't notice any deformation of the structure and the structure is in **full integrity**. Bright orange paint has disappeared.

Reached temperature inside enclosure up to 132°C

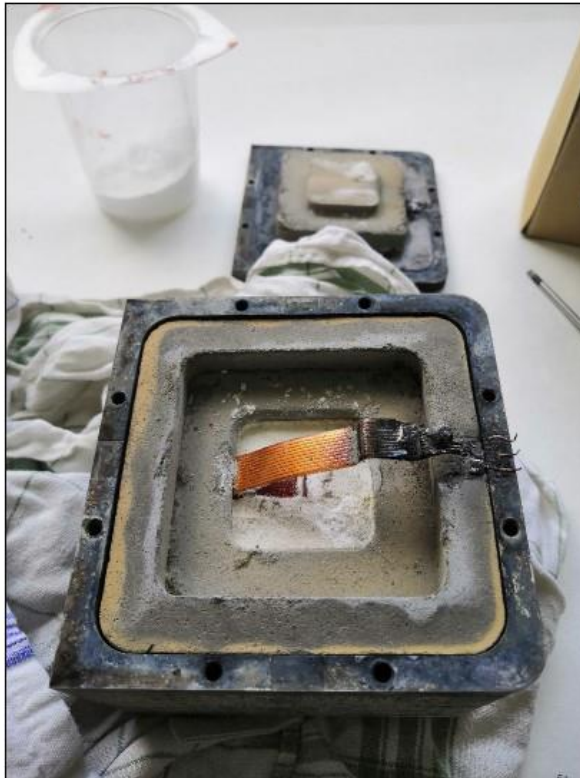
Solid state drive integrity

After this test the Sentinel crash protected memory is open to verify if the PCB did not damaged and if the data is still readable. After remove of all insulation protection (Ceramic, white powder material and red silicon protection), we examine the memory PCB.

After a visual inspection, we no detect any damages on solid state drive circuit.

The memory unit was tested to verify if the data is in full integrity.

The data is in full integrity and no present any error.

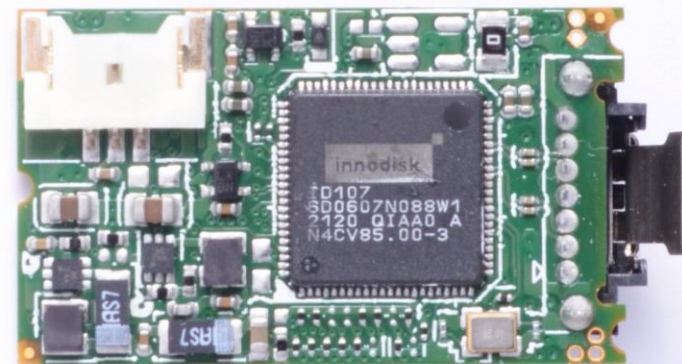
Zdemontowany chip NAND – widok z góry

Aby uzyskać dane bezpośrednio z pamięci NAND, konieczne jest wylutowanie chip'a za pomocą stacji na podczerwień przy parametrach $T_{max} = 240C$ ($T_{delta} \sim 3C/s$)

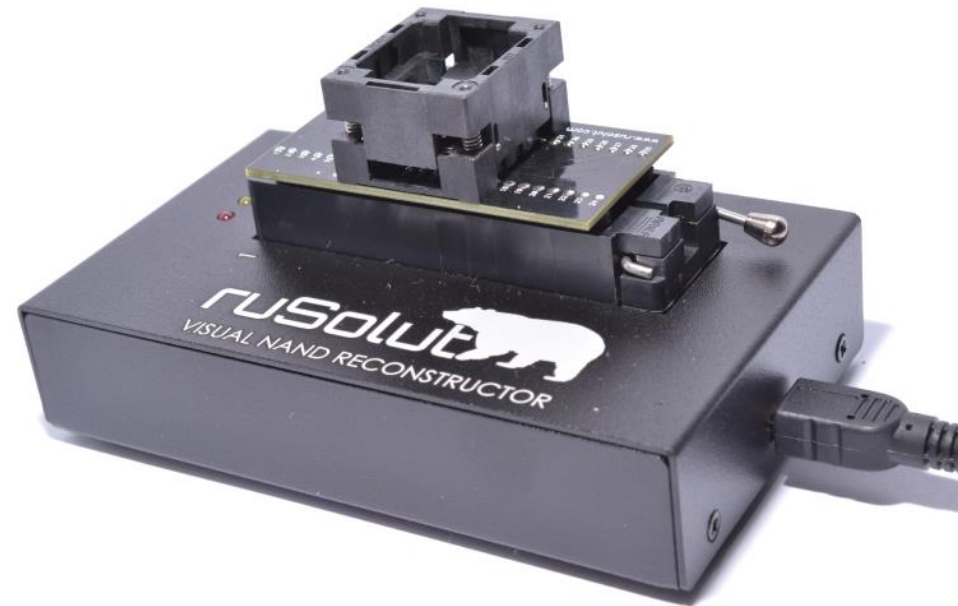
Chip identification

W pierwszej kolejności wymagany jest odczyt ID pamięci NAND.

Identyfikator 98DEA1327A należy do pamięci wyprodukowanej przez Toshiba/Kioxia

W tym układzie znajdowały się 4 płaszczyzny/kryształy.
