Flash memory technology in Aircraft Black boxes. Data recovery case studies.

Michał Gmurek, Rusolut

Data Recovery from Aircraft Black Box

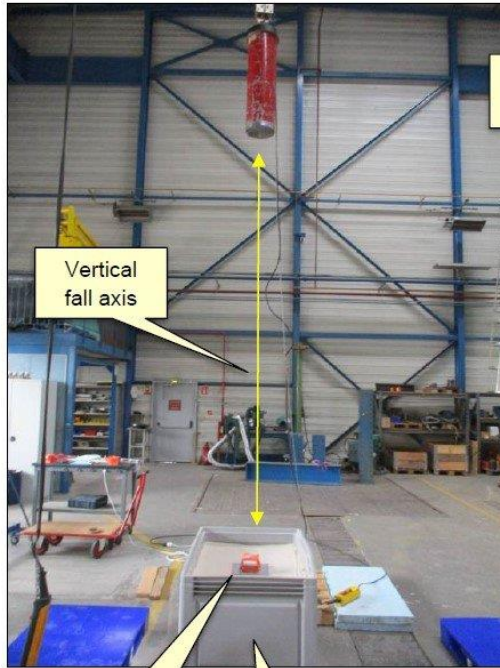
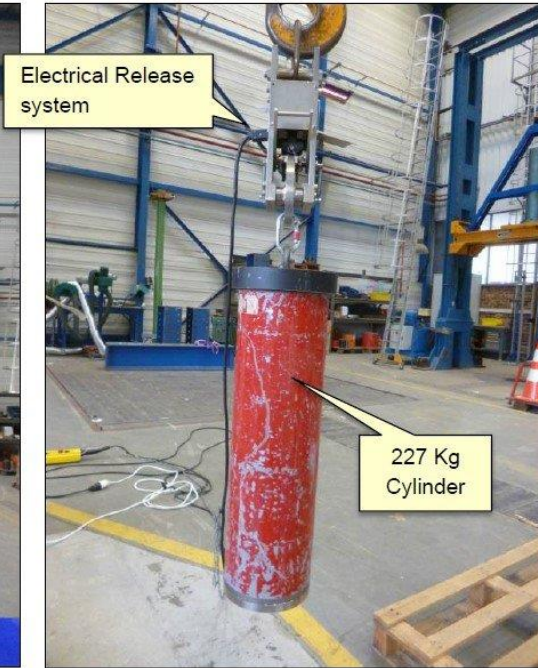
Impact test

Vertical fall axis

Electrical Release system

227 Kg Cylinder

Sentinel CSMU

Sandbox

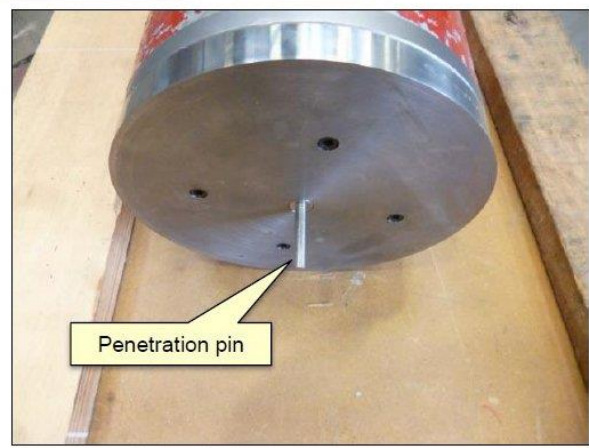
Penetration pin

Steel plate

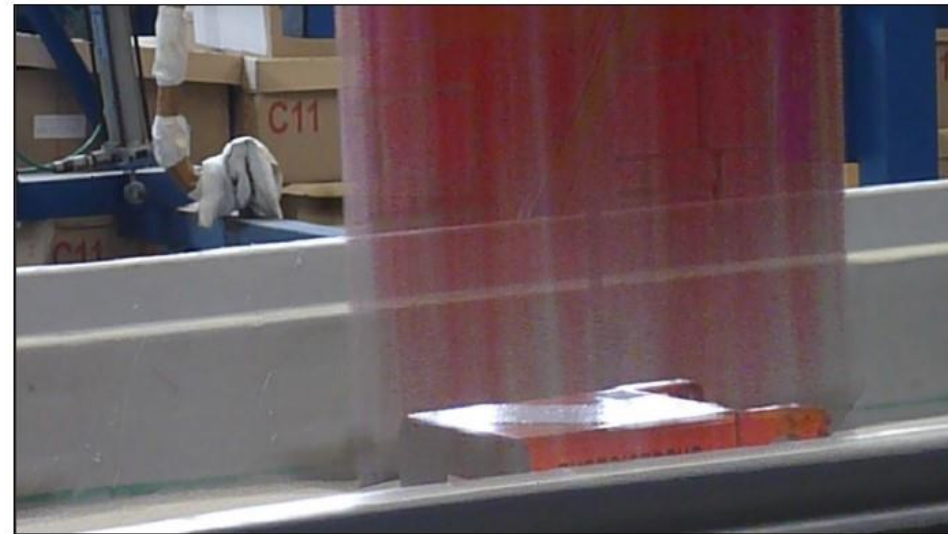
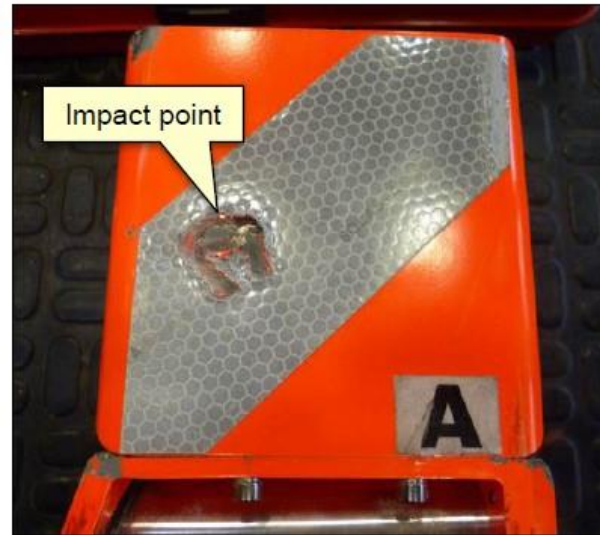
Mechanical crash test results

CSMU "A", "B" and "C" has successfully pass test sequence, no penetration or deformation of structure has been noted for each one.

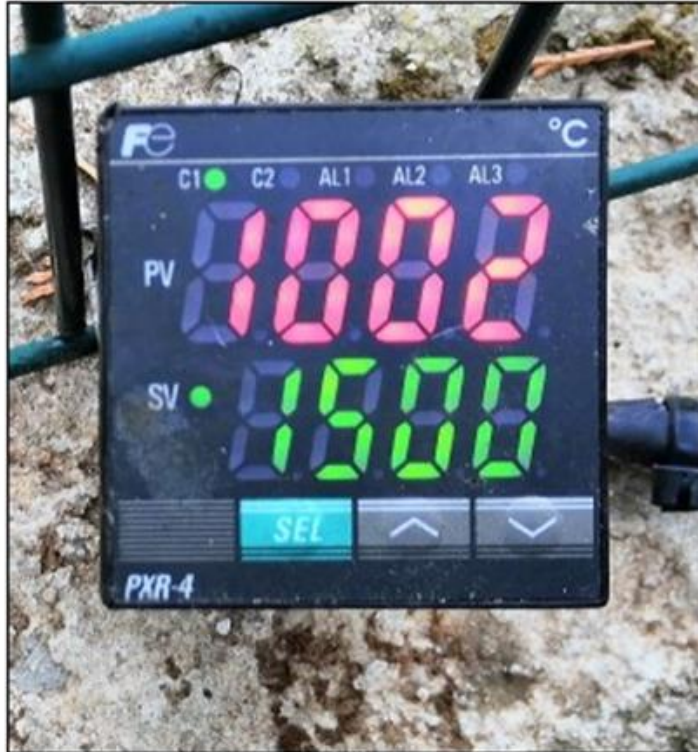
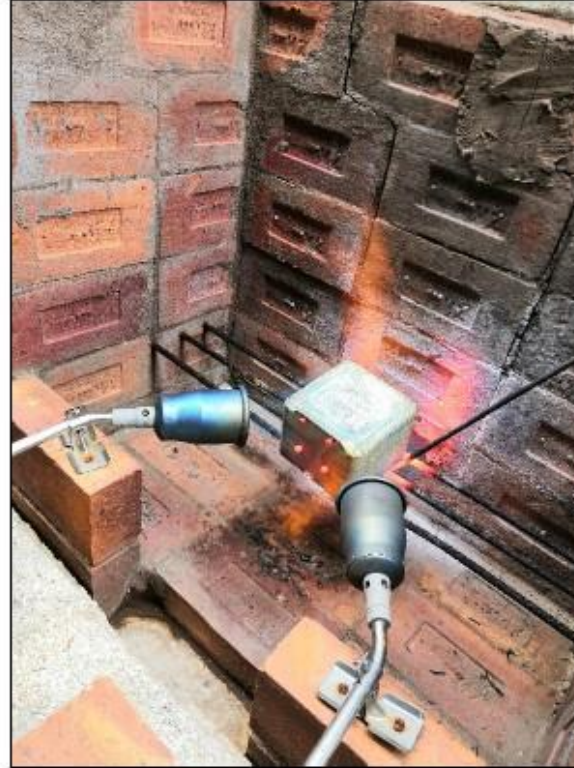
High temperature test

Test has been conducted on Crash Protected memory unit destined to equip Sentinel System. The fire test is started by turning on the main gas valve. Flame temperature, as indicated by the external thermocouples, is continuously monitored. Figure 2 picture show Crash Protected Memory module under high temperature test.

At the end of the test period, the burners have been shut off and the robust memory module has been cool naturally in ambient conditions. The crash Protect memory unit has been removed from the vicinity of the support arrangement.

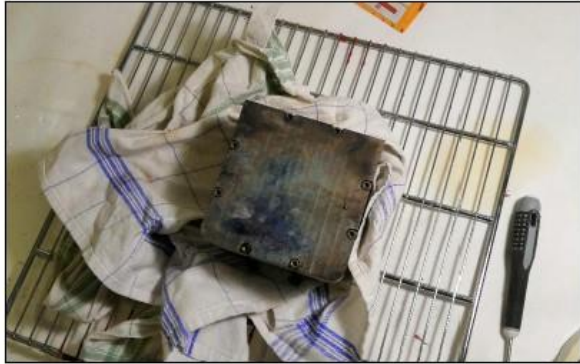
High temperature test results

The unit is progressively put back to room temperature (natural cooling) the time is approximatively 3 hours before being able to go for opening process.

we don't notice any deformation of the structure and the structure is in **full integrity**. Bright orange paint has disappeared.

Reached temperature inside enclosure up to 132°C

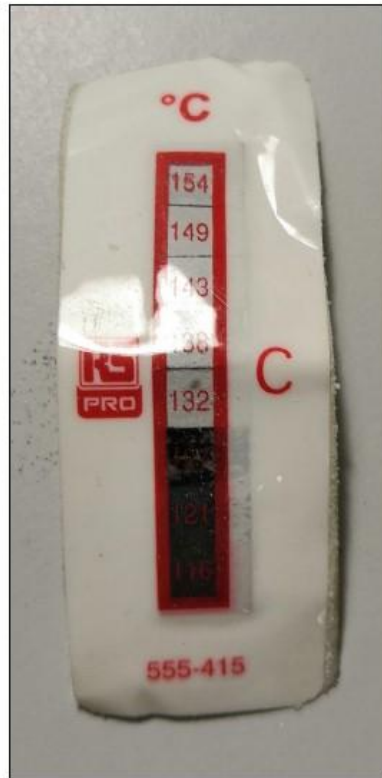
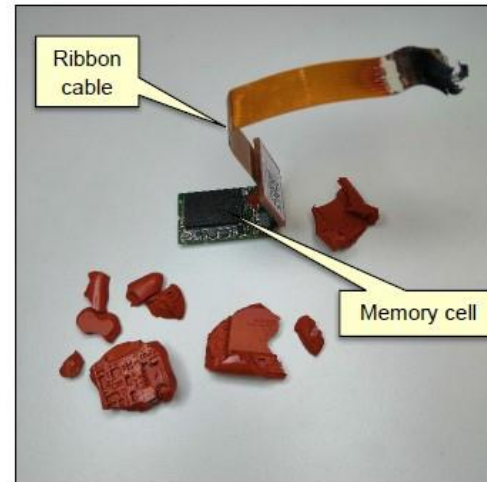
After this test the Sentinel crash protected memory is open to verify if the PCB did not damaged and if the data is still readable. After remove of all insulation protection (Ceramic, white powder material and red silicon protection), we examine the memory PCB.

After a visual inspection, we no detect any damages on solid state drive circuit.

The data is in full integrity and no present any error.

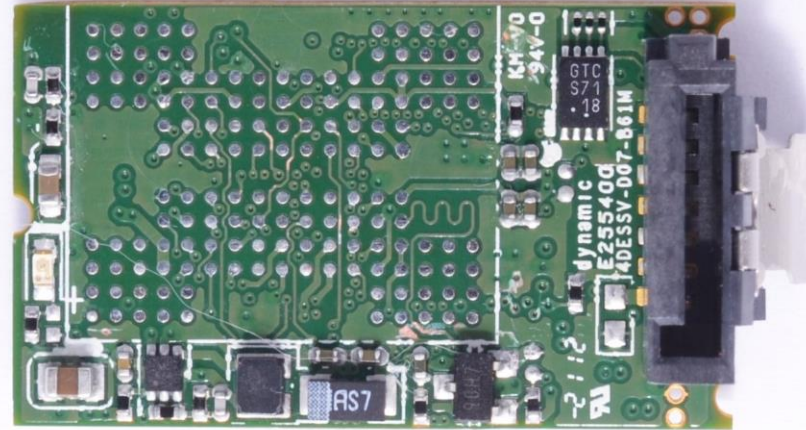
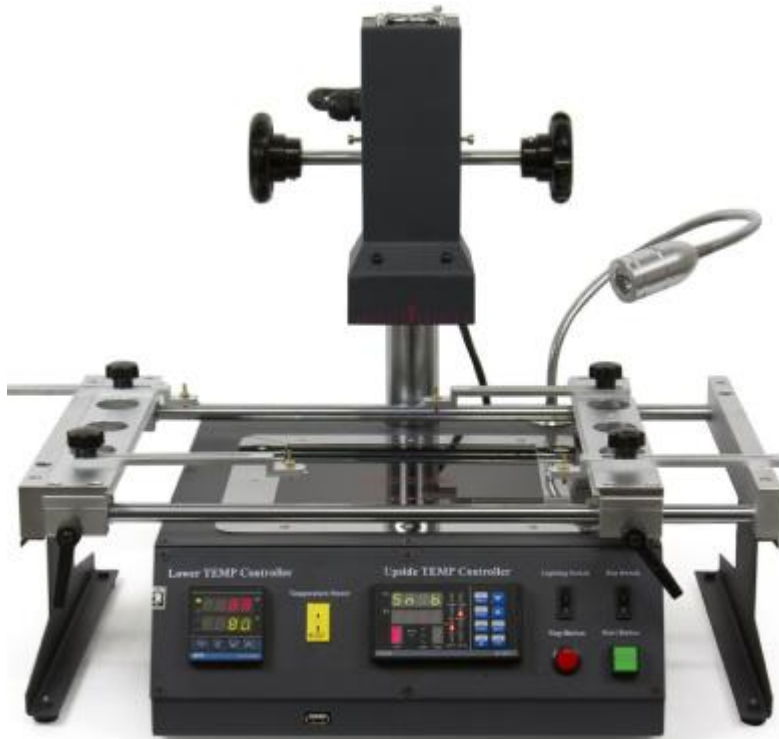
Unsoldered NAND memory – top view

The memory chip was removed from the PCB for further reading using InfraRed rework station and thermal profile of Tmax = 240C (Tdelta ~ 3C/s)

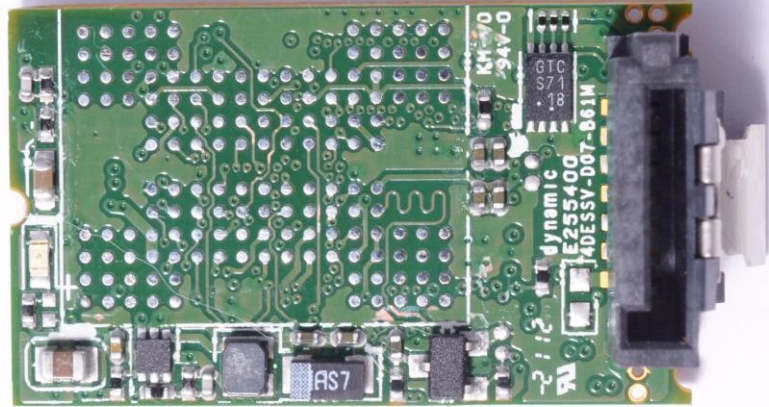
Unsoldered NAND memory – ball view

The NAND memory has BGA-132 package which is classics for high-capacity memory chips. The pads of NAND memory chip have been cleaned with solder wick and then isopropyl alcohol.

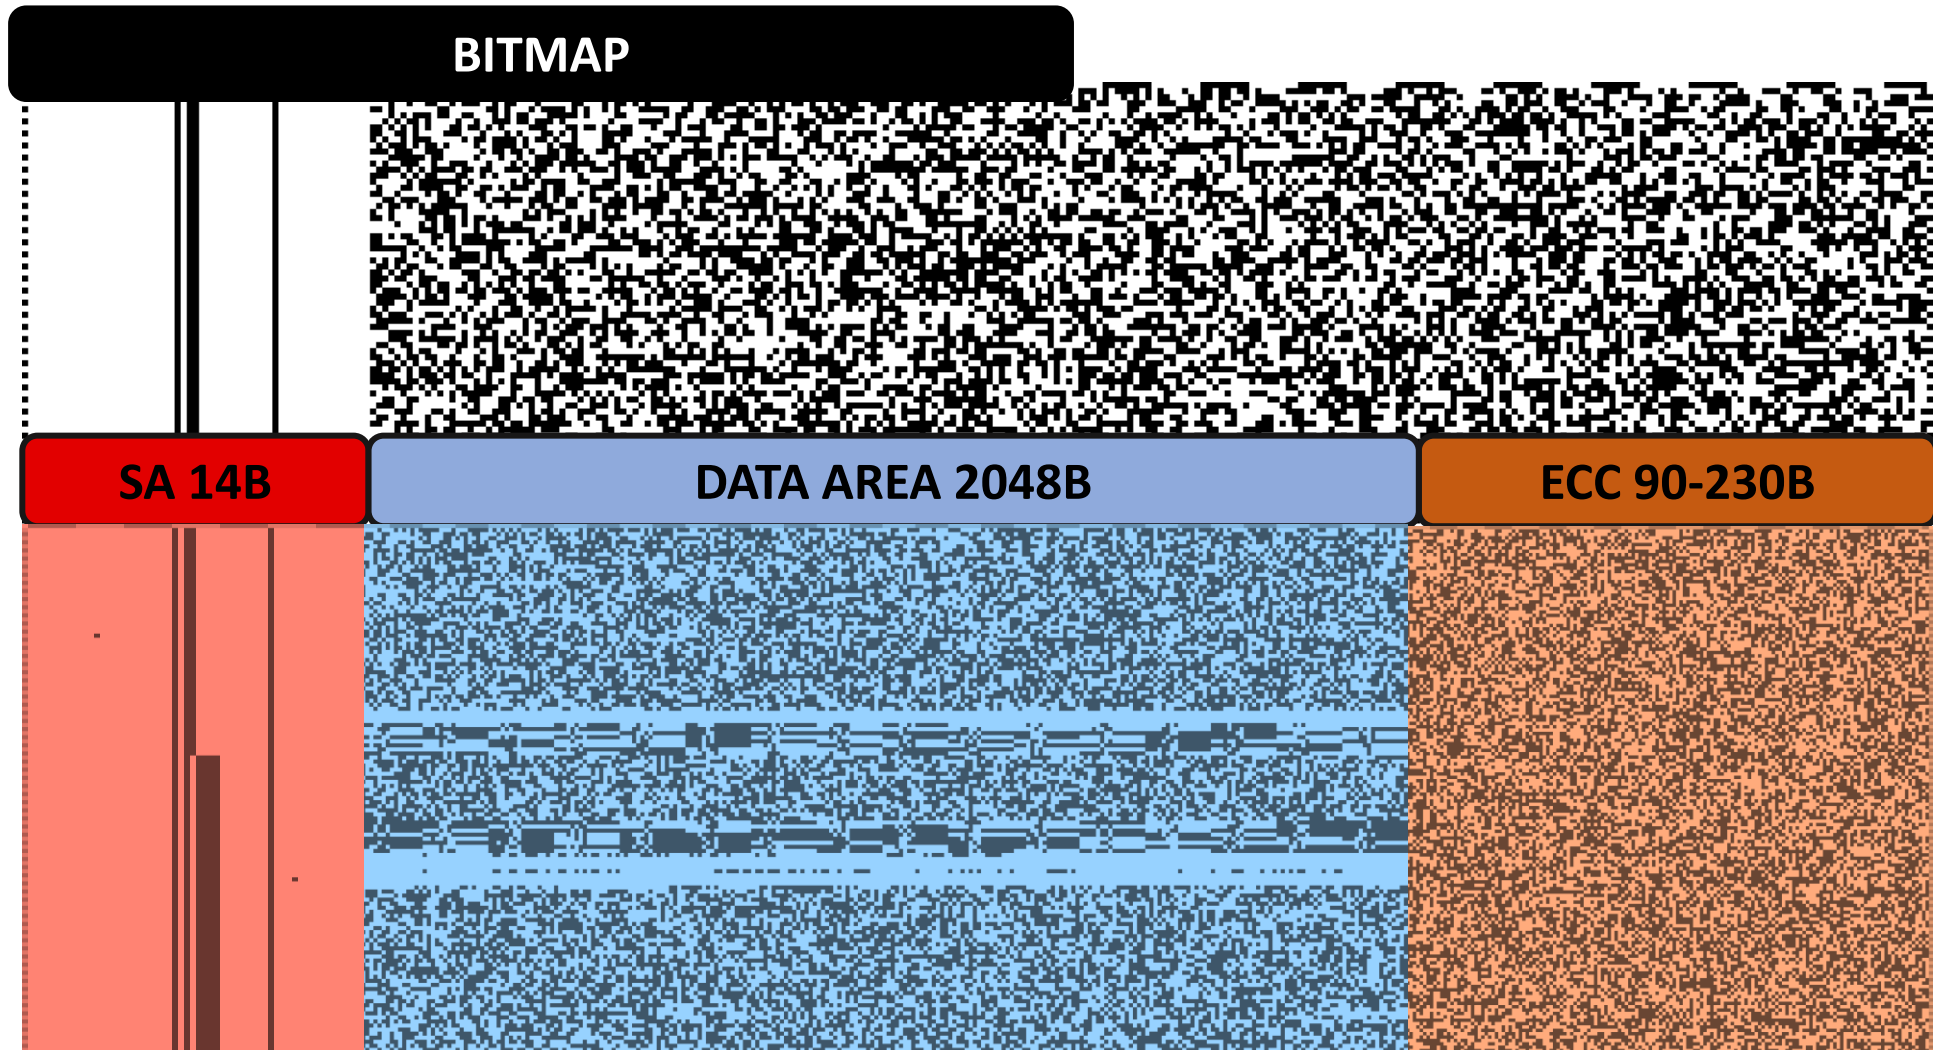
Page layout

Scrambled data
1024 bytes

ECC
10-250 bytes

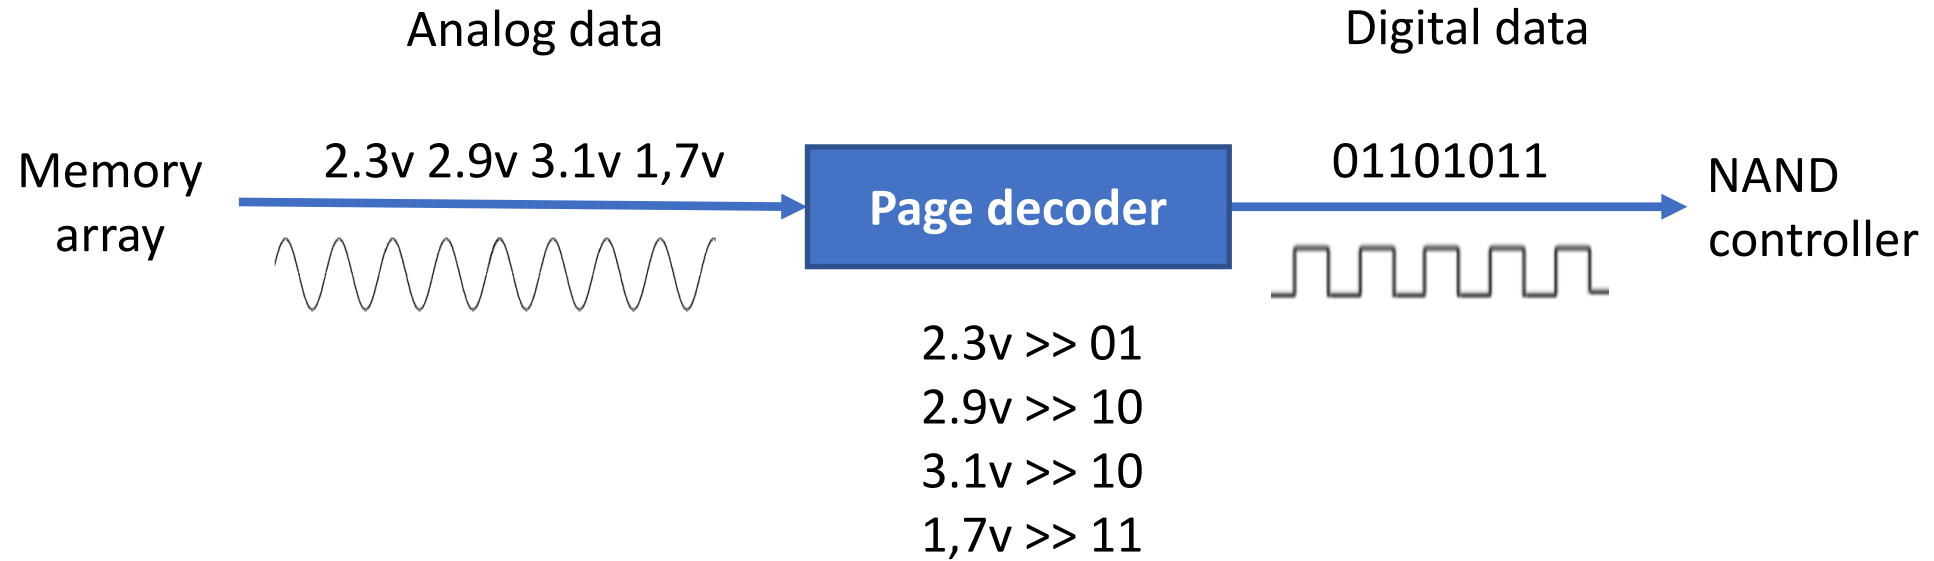
Page decoder

Analog states from cells are converted into digital data

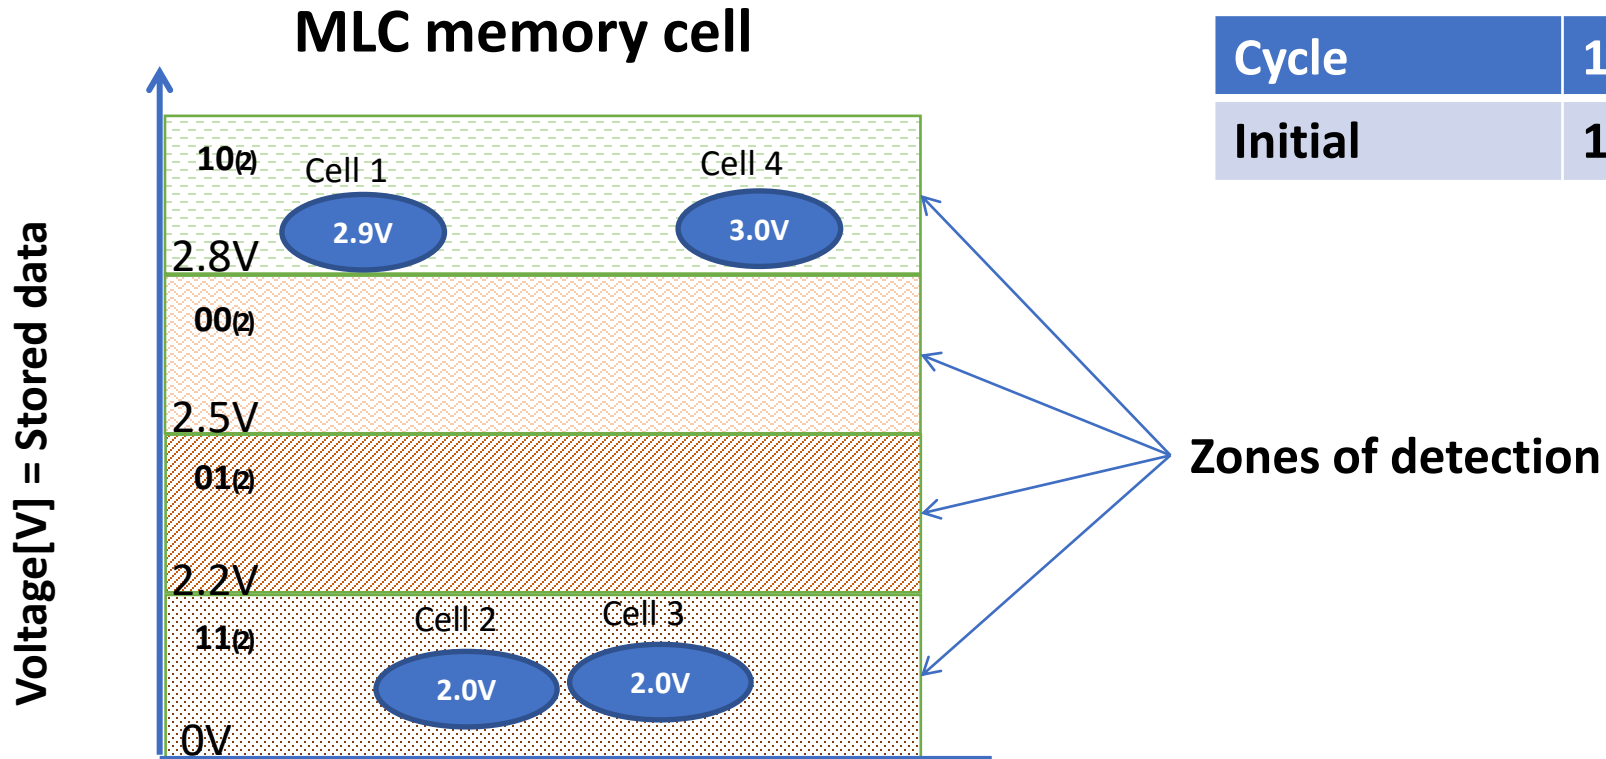
Bits inside memory cell

The data in cell is stored as a voltage level

Controller is reading data according to specific zones

Cycle	1	2	3	4	HEX
Initial	10	11	11	10	BE

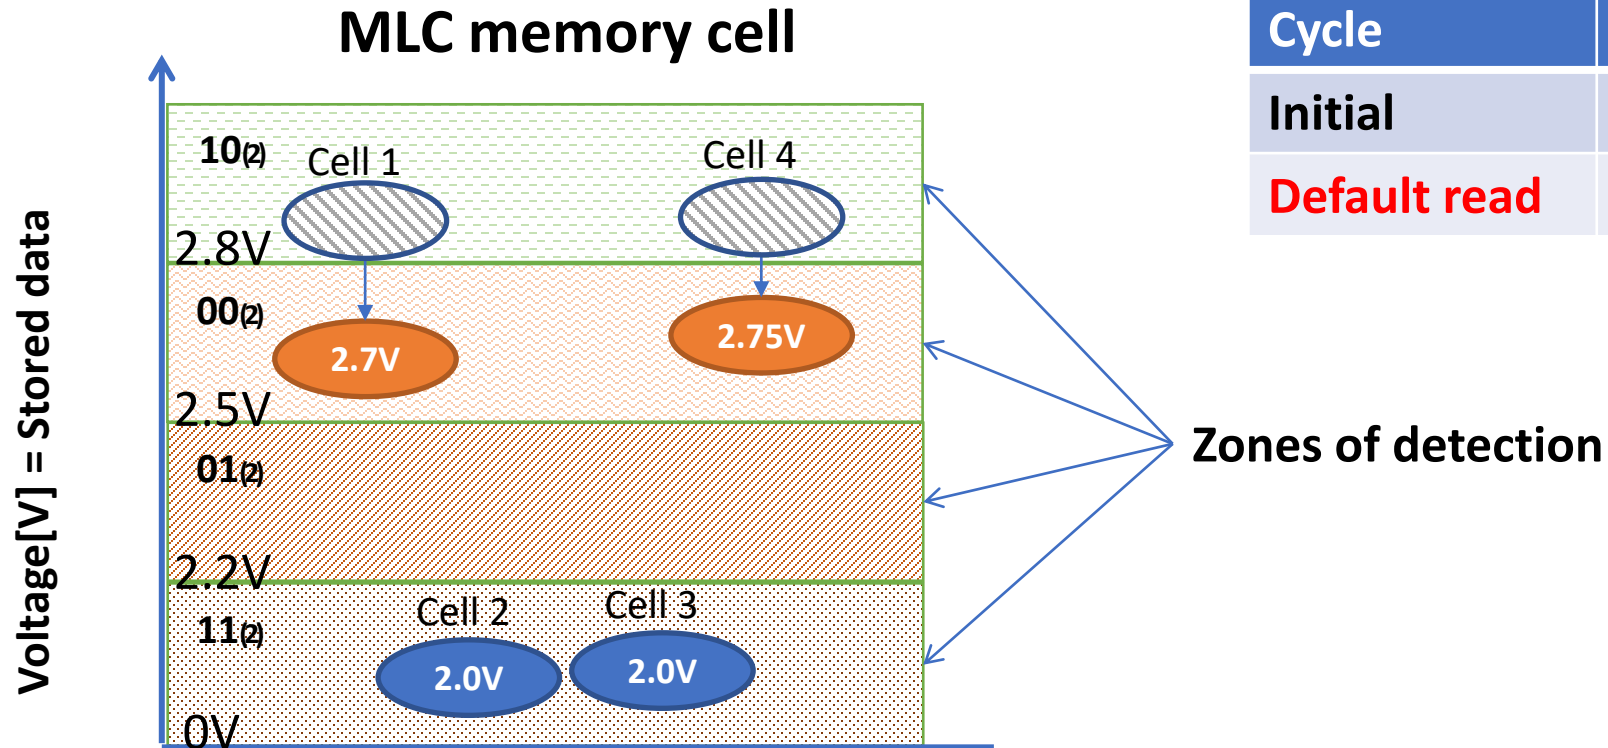
Retention Error

When charge leaks out from cell we get bit error

Cycle	1	2	3	4	HEX
Initial	10	11	11	10	BE
Default read	00	11	11	00	3C

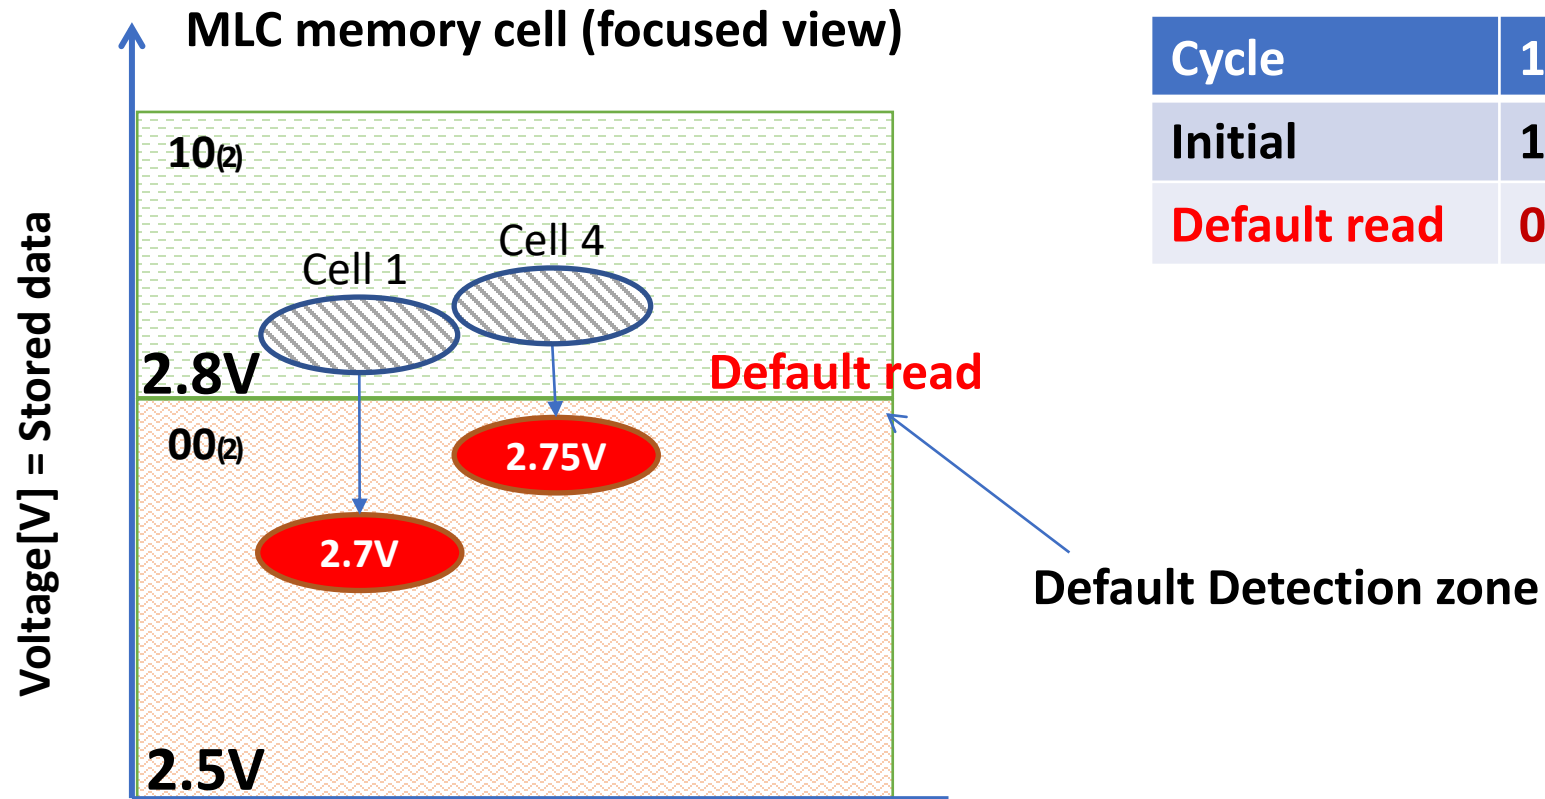
Read-Retry Mechanism

When charge leaks out from cell we get bit error

Degraded cell gives wrong data

Cycle	1	2	3	4	HEX
Initial	10	11	11	10	BE
Default read	00	11	11	00	3C

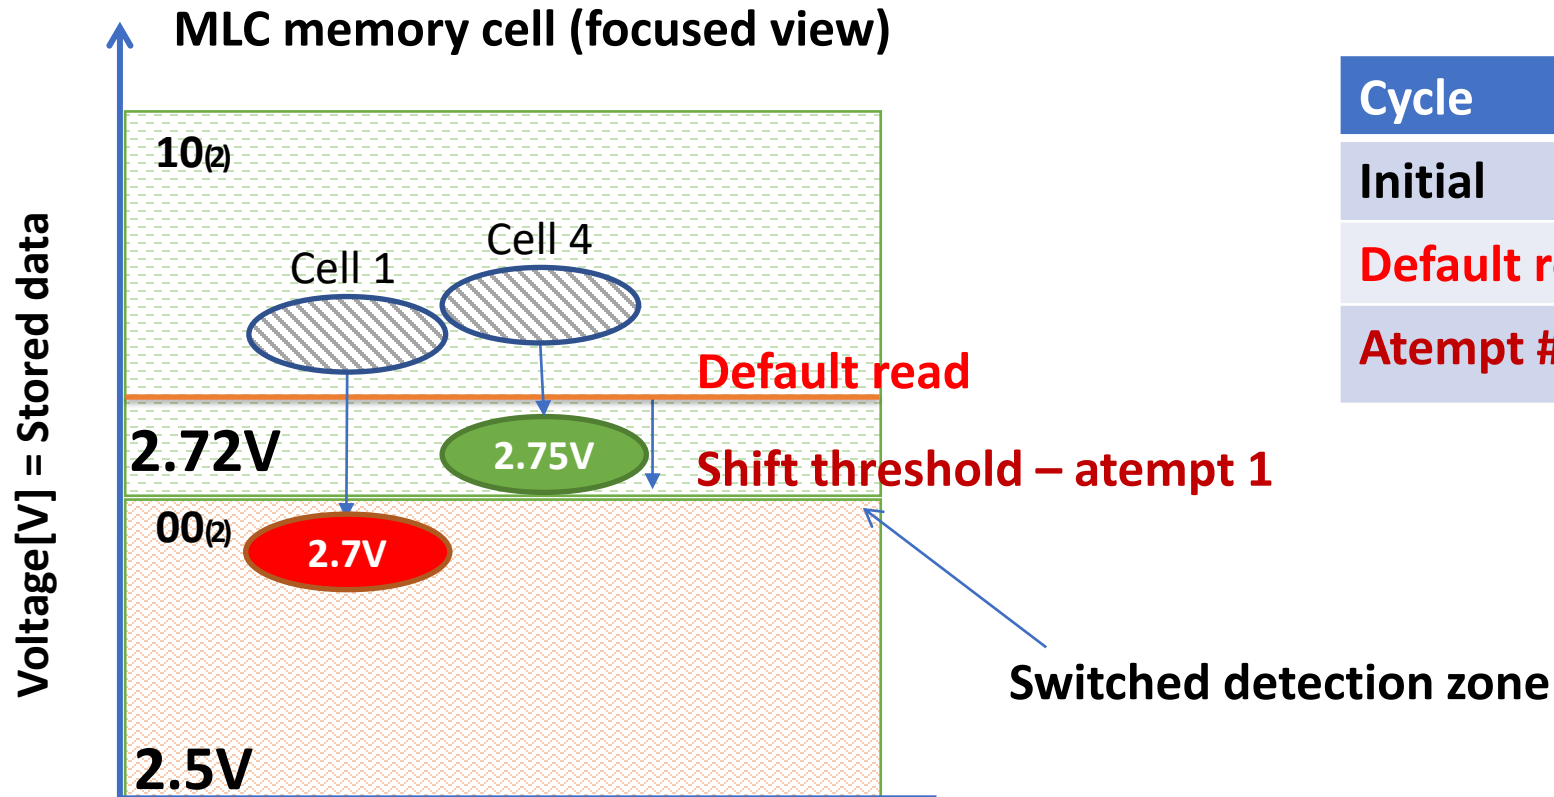
Read-Retry Mechanism #1

Read retry mechanism helps to shift read voltage thresholds

Cycle	1	2	3	4	HEX
Initial	10	11	11	10	BE
Default read	00	11	11	00	3C
Attempt #1	00	11	11	10	3E

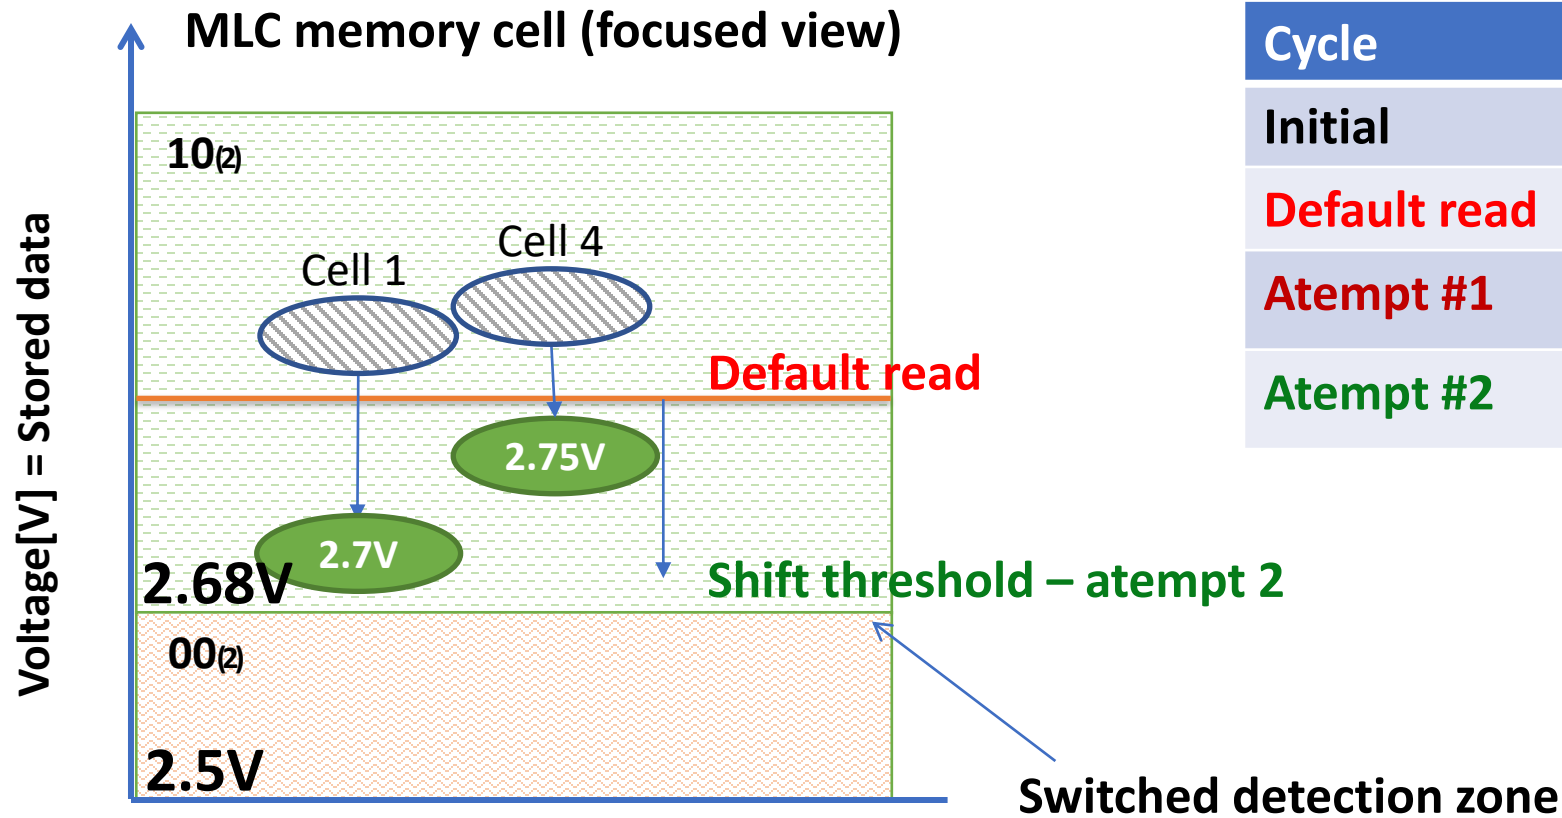
Read-Retry Mechanism #2

Read retry mechanism helps to shift read voltage thresholds

Cycle	1	2	3	4	HEX
Initial	10	11	11	10	BE
Default read	00	11	11	00	3C
Attempt #1	00	11	11	10	3E
Attempt #2	10	11	11	10	BE

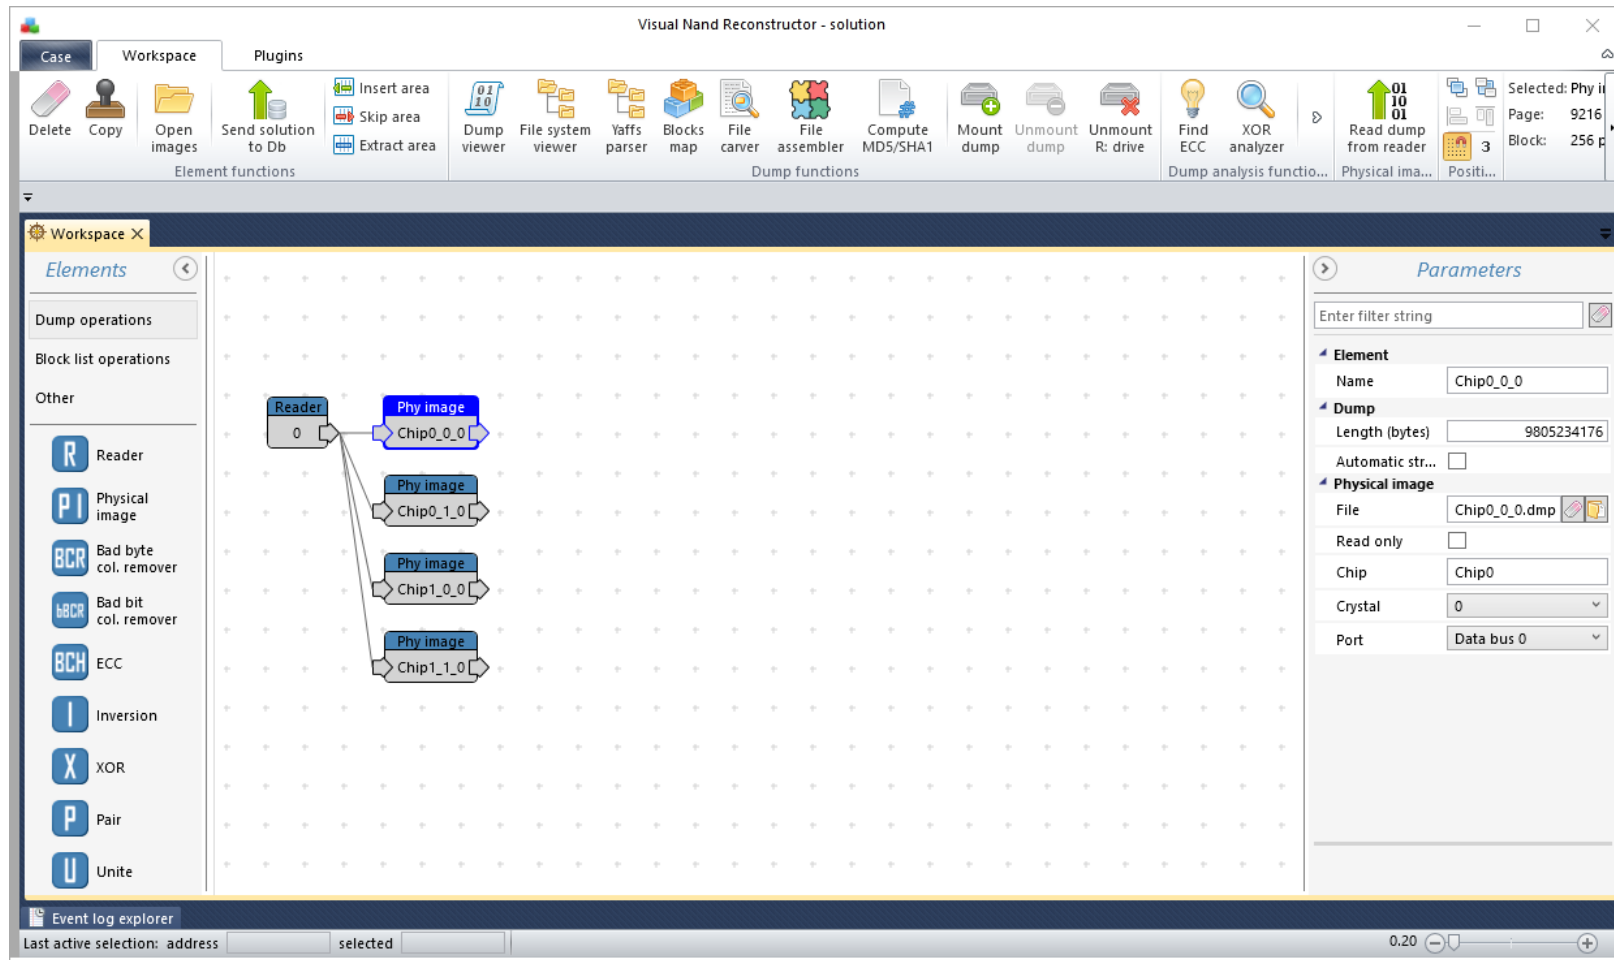
Physical image extraction from NAND

We used Visual NAND Reconstructor for memory chip reading and physical image processing. In total 4 dumps/physical images were extracted out of the NAND.
